PROPERTY INSPECTION REPORT

Prepared for: John and Jane Doe

Address: Any Street, Texas 75000

1/11/2016

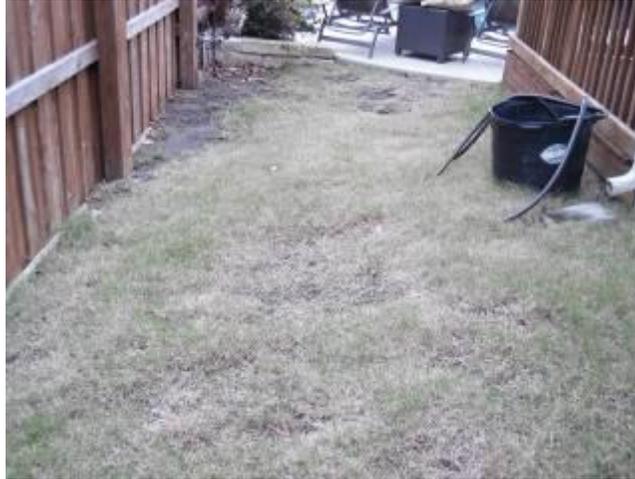
B. Grading & Drainage – Comments: Down spouts diverters should be turned around for better drainage. Some west side grass washed away, it may be difficult to grow grass in that shadowed area.

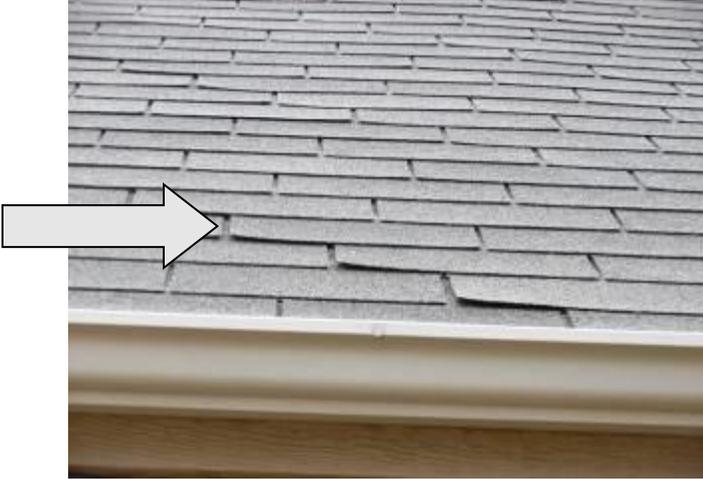
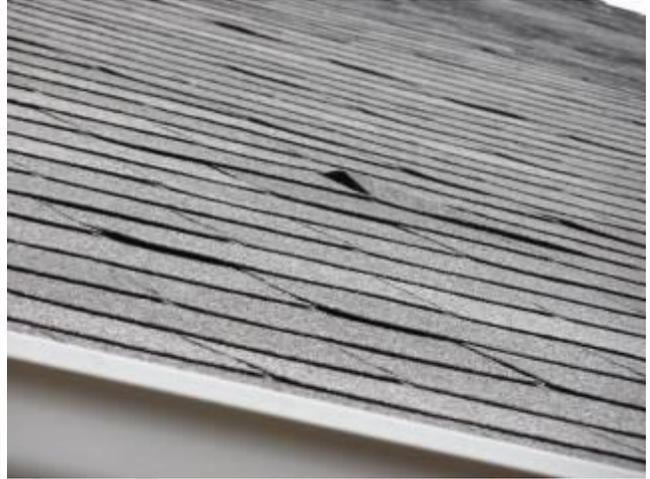
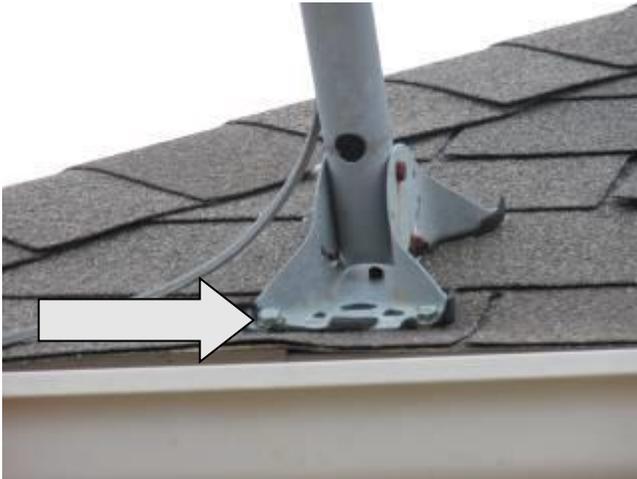
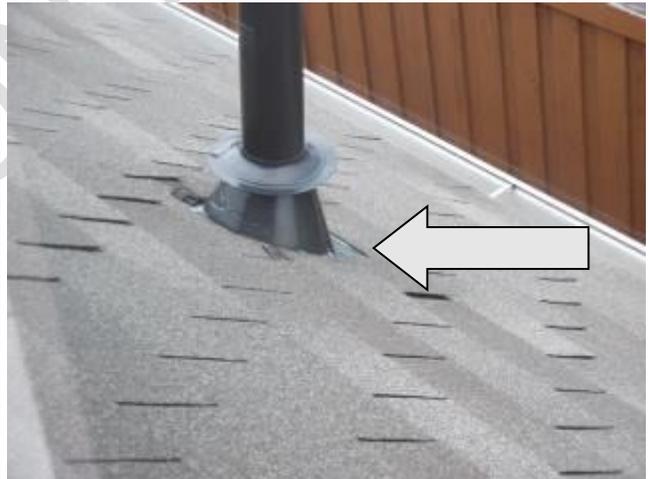
Comments: Many shingles have edges curling, the edges are not secure to the shingle underneath. Some of the satellite mounting bolts should be chalked. Roof vent not flashed properly the shingle material is over the bottom part of the flashing. Roof should be further evaluation by a qualified roofer.

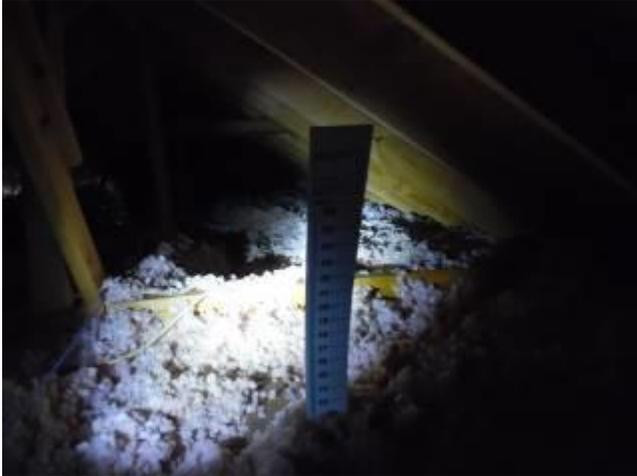
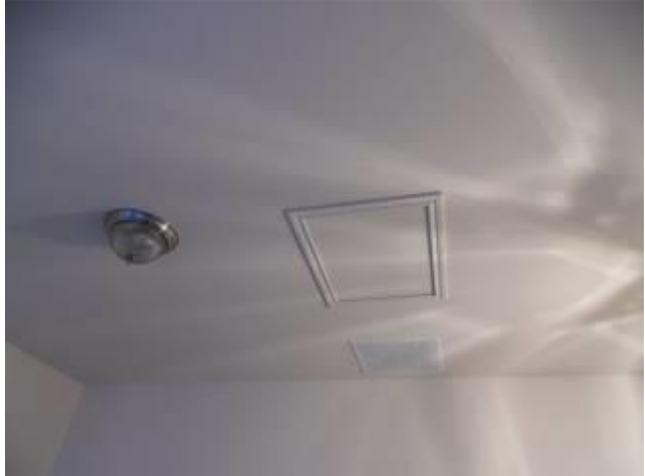
Approximate Average Depth of Insulation: 6 to 12 inches, should be 12 to 14 inches.

Comments: Game room Attic hatch should be insulated more.

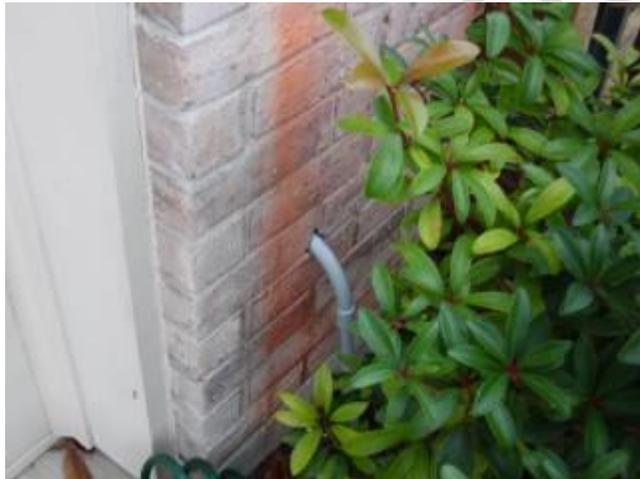
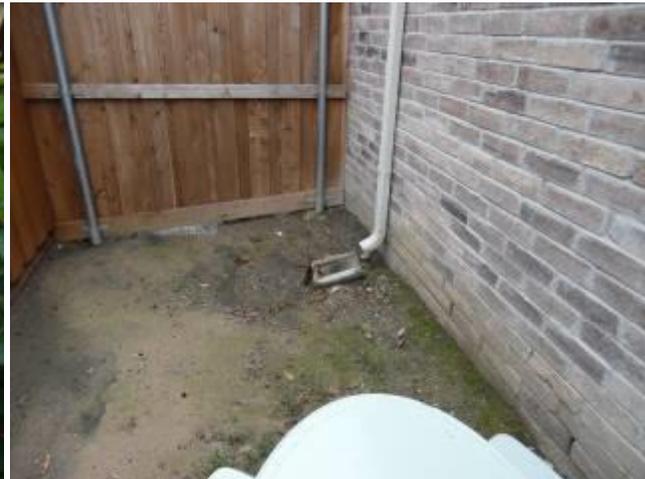
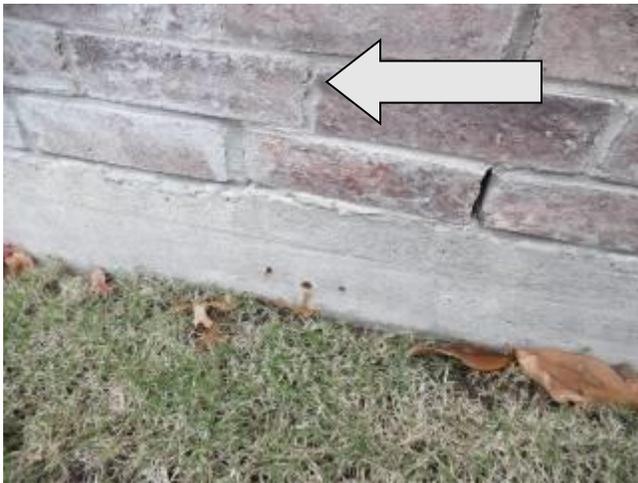
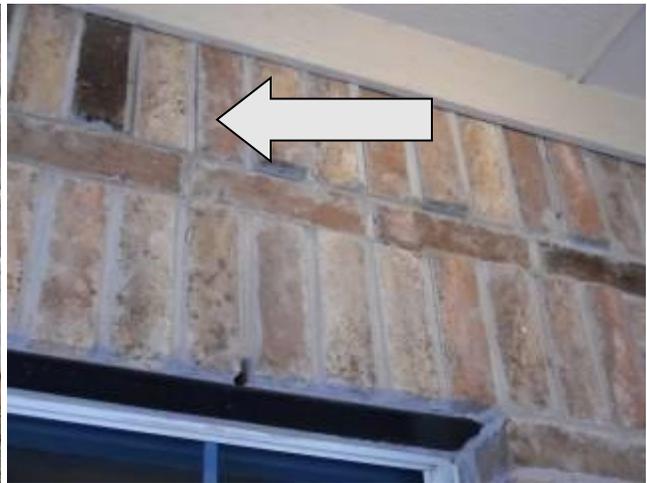
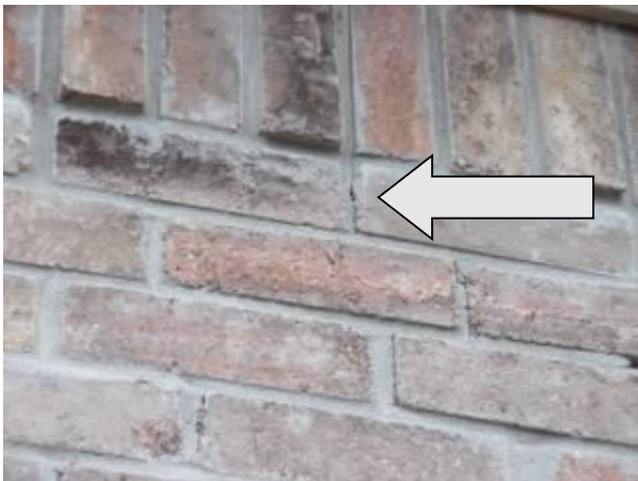
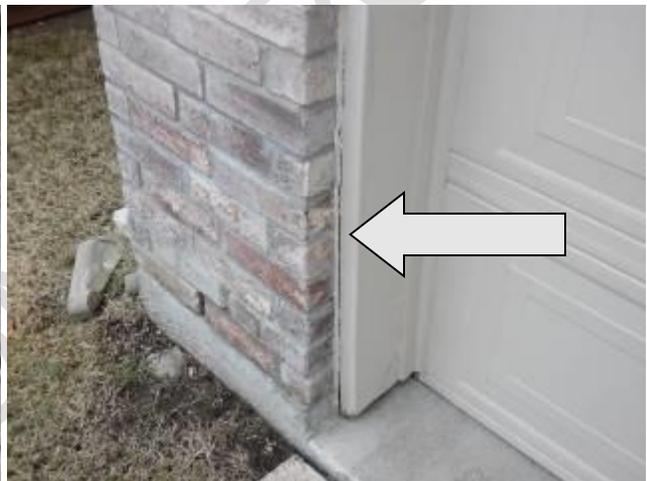
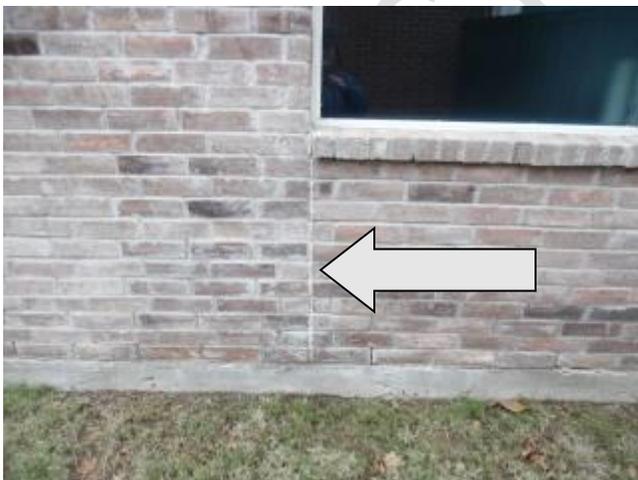
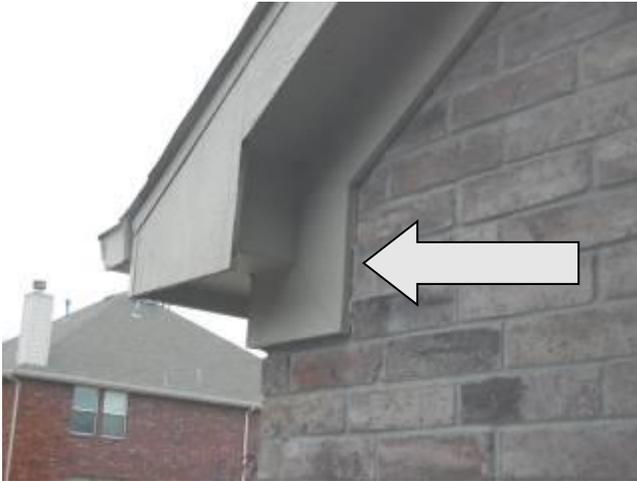
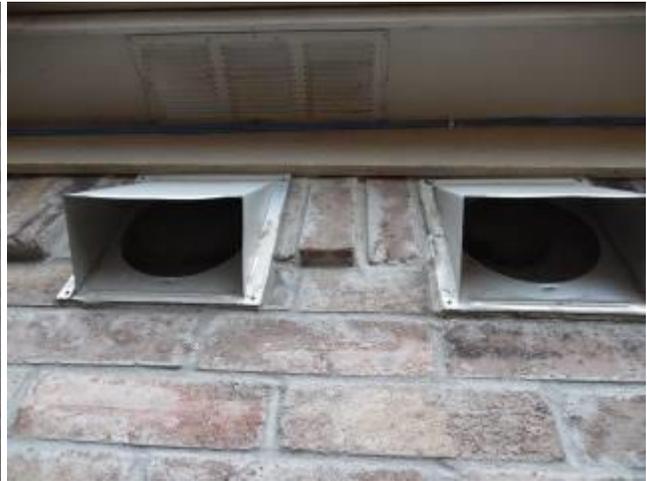
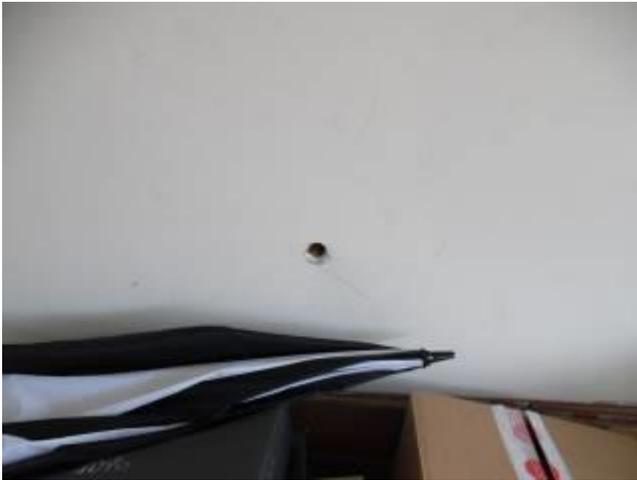
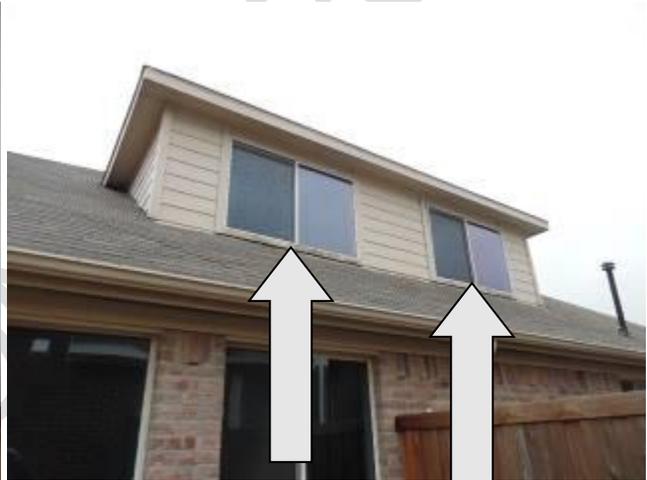
Comments: Bushes and fencing should not touch walls. Many of the bricks mortar needs repointing. Garage trim needs rechalking and expansion joints need to be rechalked as they are hard. Breakfast area ceiling joint is cracked and holes in wall board. Nail pops were covered over in wall above sink in master math. Frieze board on the patio by the living room needs calking. Oven vents need calking and screens have lint. Garage wall has hole in west side. Upstairs windows wood trim on the bottom seems to be more weather worn than the side trim and should be looked into for deterioration by a contractor.

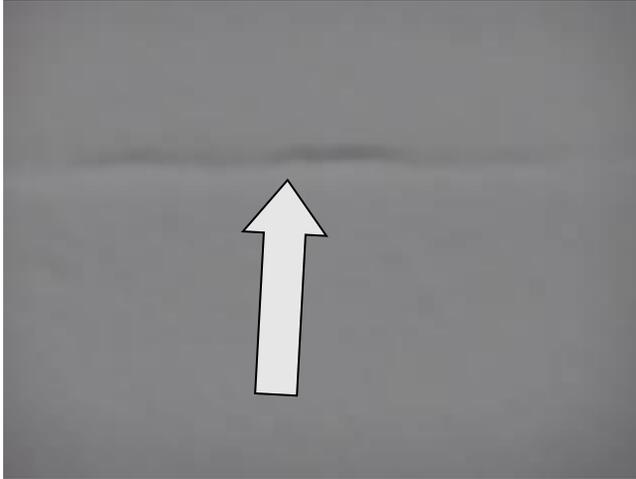
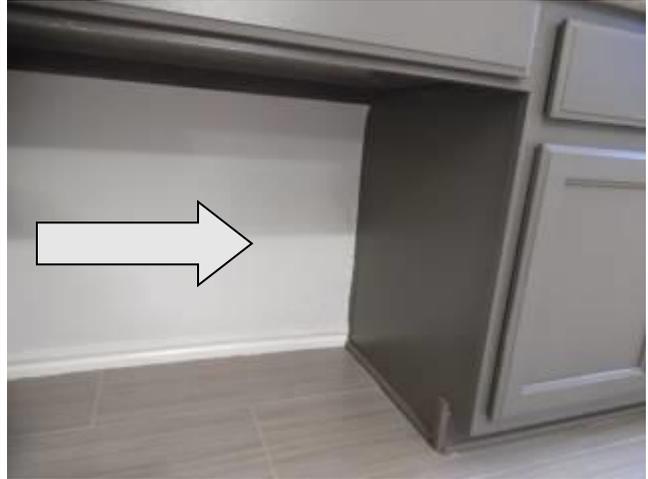
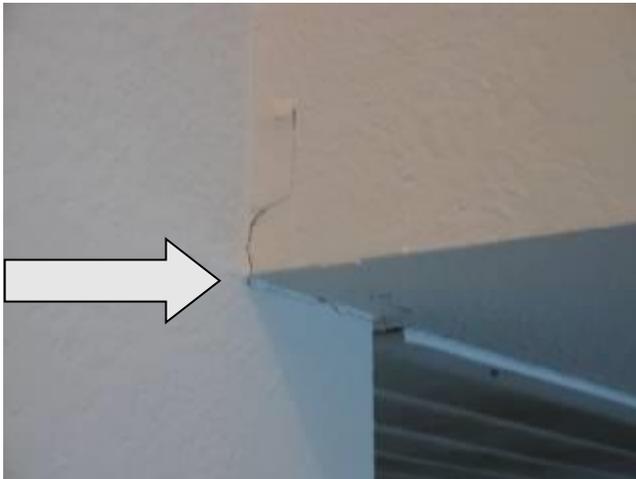
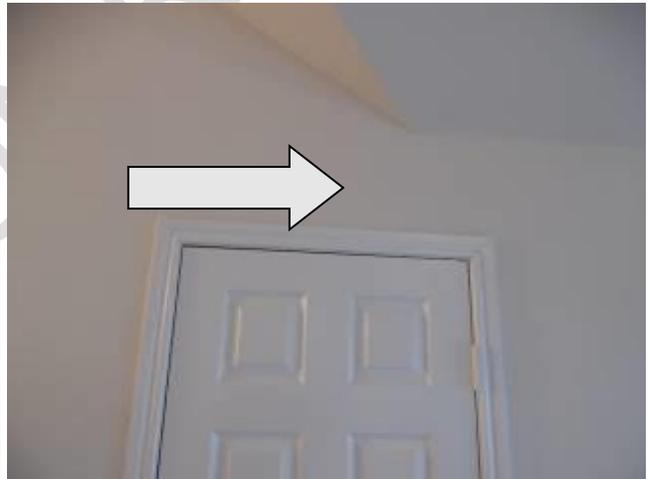
F. Ceilings & Floors – Comments: Breakfast area ceiling joint is cracked and holes in wall board. Under master bath vanity has patched wall. Wall board crack in ceiling and wall by downstairs return air vent which has bent up corners and edges. Crack over access door to attic. Master bed room floor looks like it was patched with a different color of flooring.

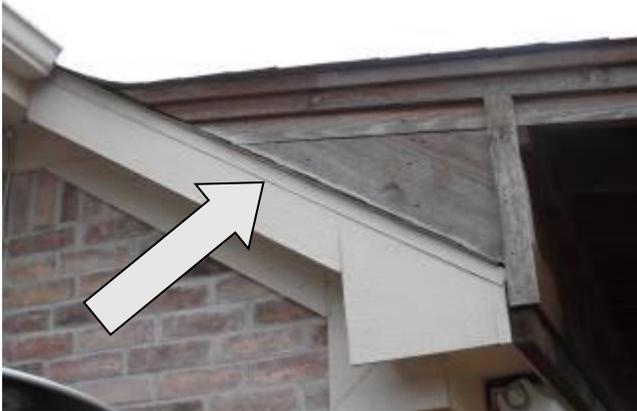
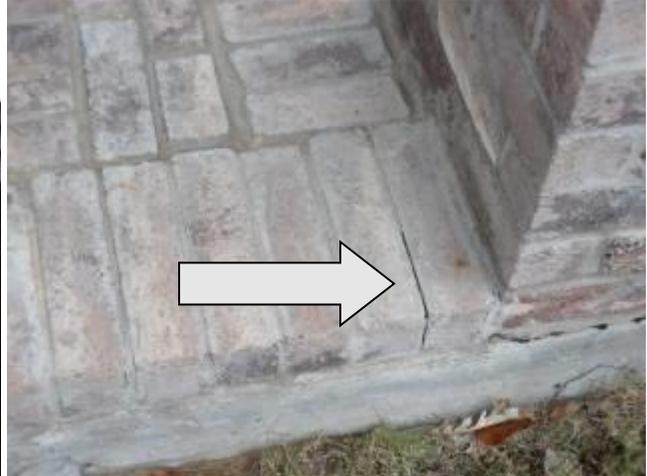
K. Porches, Balconies, Decks, and Carports – Comments: Patio cover appears to have been built incorrectly as the beams seem to be mounted on the roof shingles and are not flashed properly and should be further examined by a qualified contractor. Some porch bricks need repointing.

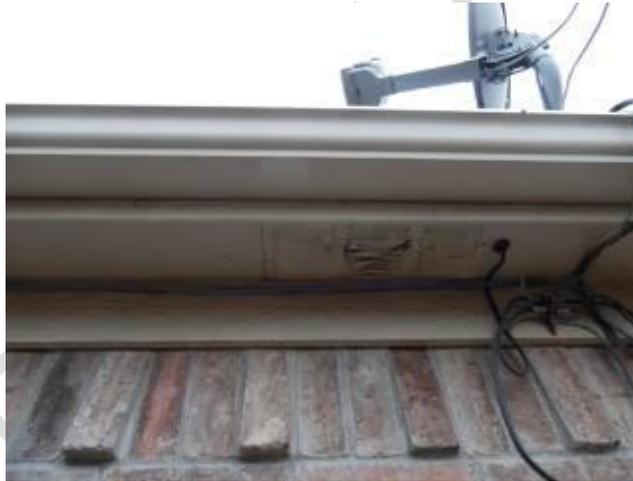
L. Other – Comments: Soffit vents on east side have peeling paint.

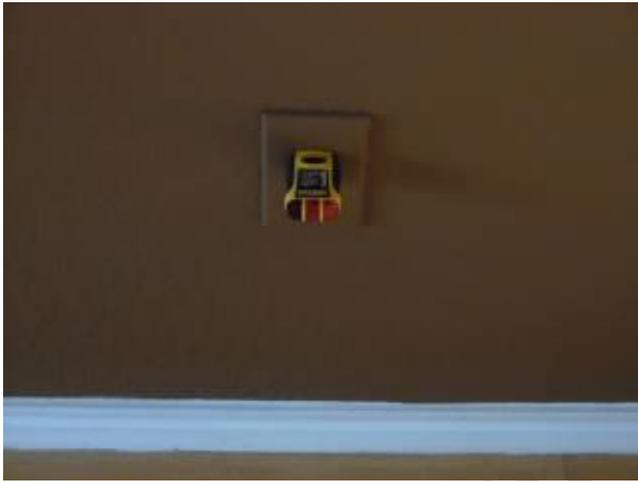
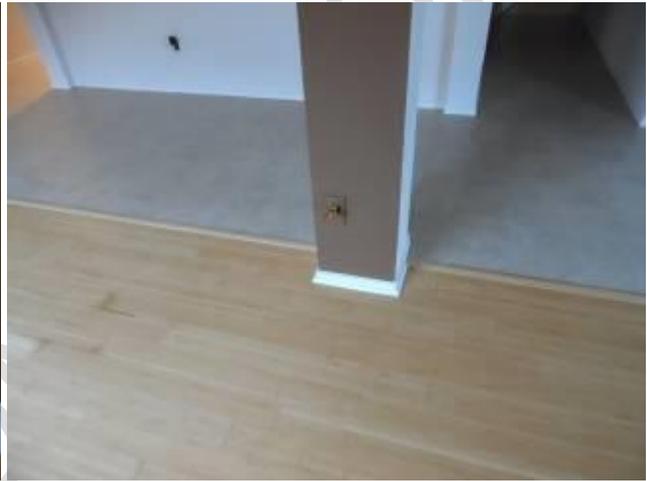
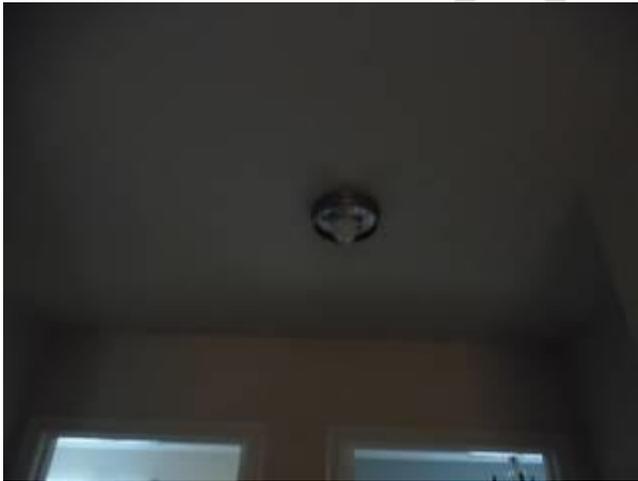
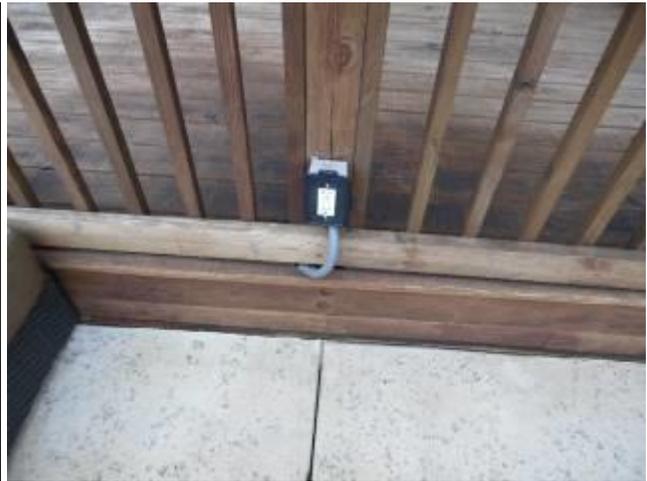
Comments: Two sockets did not work in the dining room. Most wall plugs in the house were painted over and it was hard to insert my tester, few were impossible. Hall and media rooms light covers were not on the lights. 2 of 6 dining room lights did not work. Outside by the pool the weather socket cover was missing.

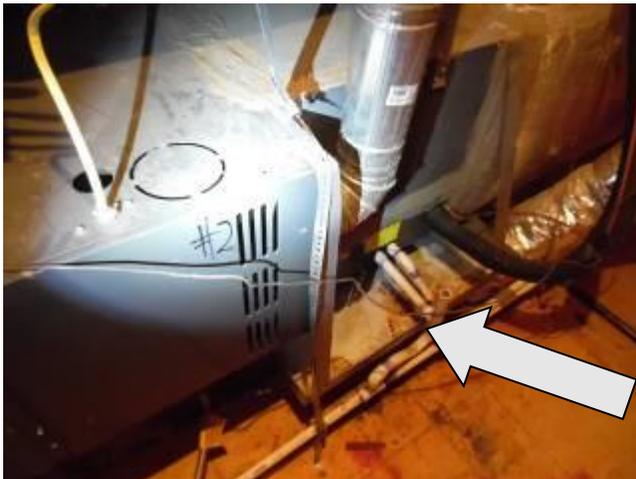
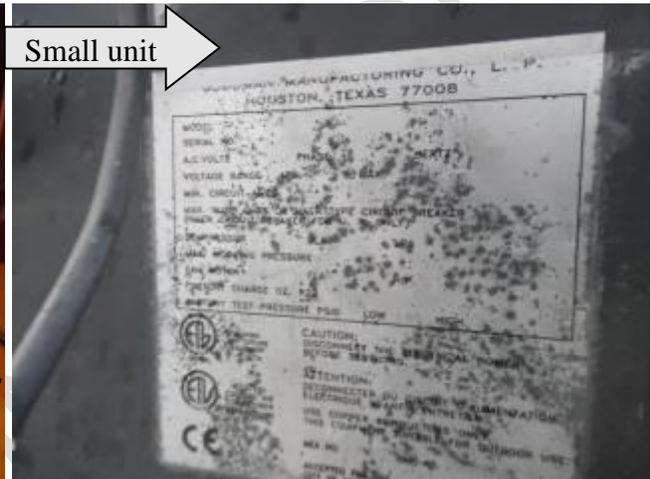
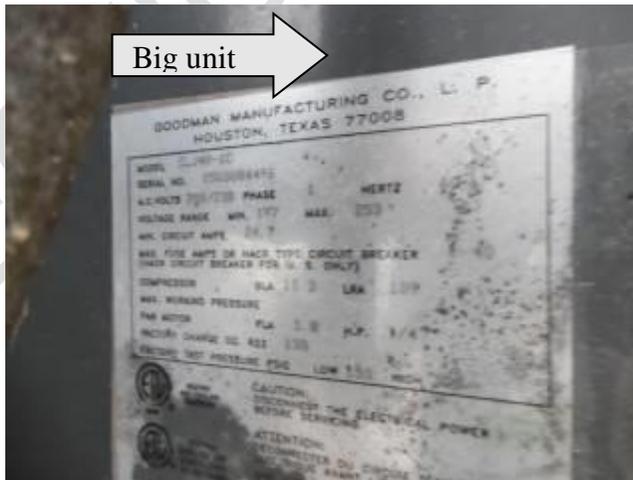
Comments: The compressor operated within the appropriate temperature range. Unit #2 had a small amount of rust in the secondary drip pan.

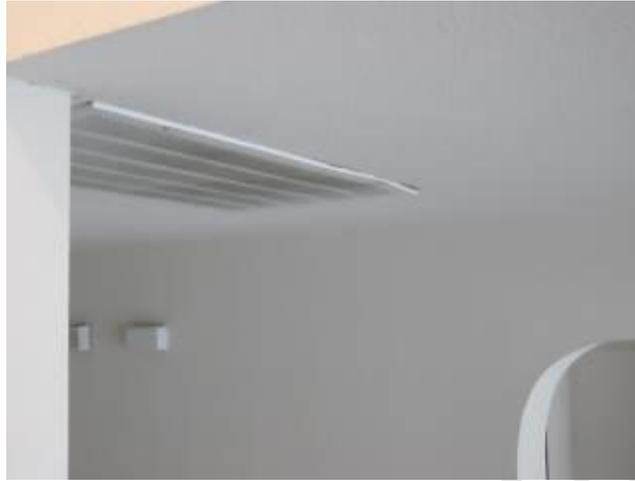
C. Duct System, Chases, and Vents – Comments: Downstairs return air vent was bent

up.

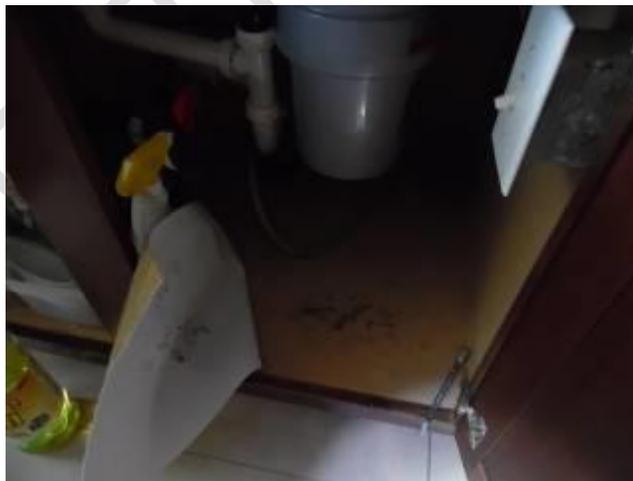
B. Drains, Wastes, and Vents – Comments: Front bath room sink stopper does not work. Kitchen sink cabinet bottom has evidence of a leak as the bottom was blistered and had mold growth under the mat.

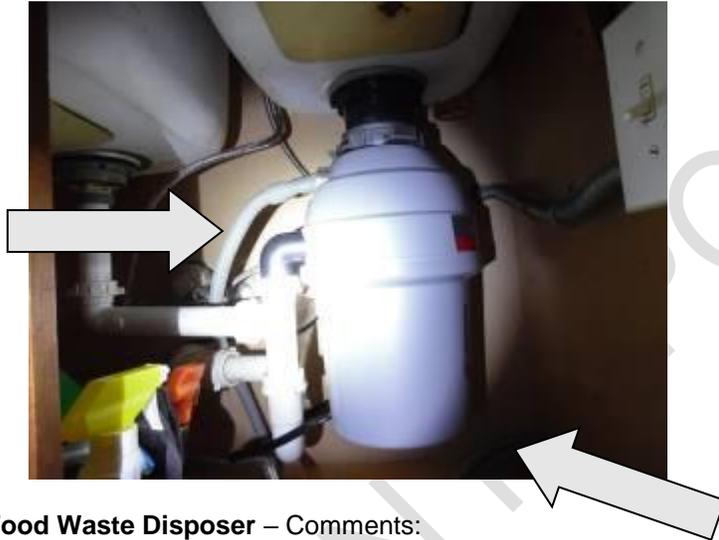
A Dishwasher – Comments: Ran through a normal cycle. Drain does not have a high loop to keep disposal backwash from the dishwasher.

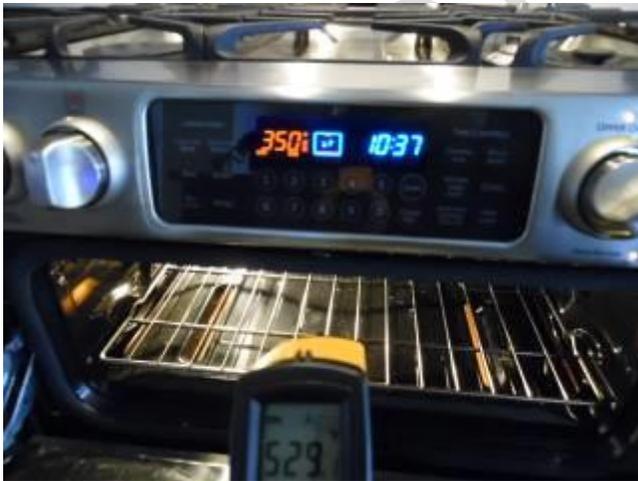
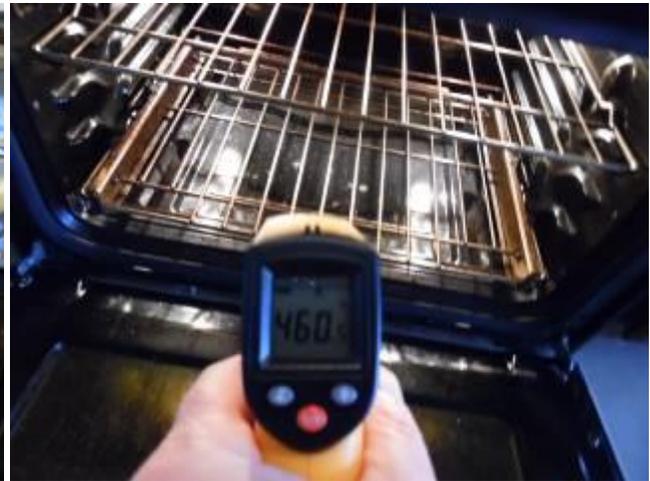
D. Cooktop and Ovens – Comments: Gas. Bottom oven is Gas/ Electric. Both ovens temperatures need calibrating they run too high. Should be plus or minus 25 degrees both were over 100+.

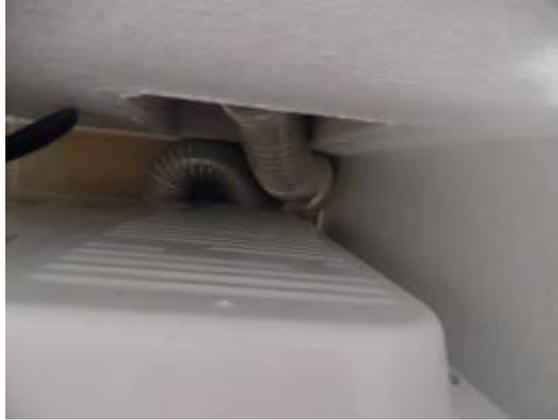
H. Dryer Exhaust Systems – Comments: Exhaust should be non-flexible and be as straight as possible.

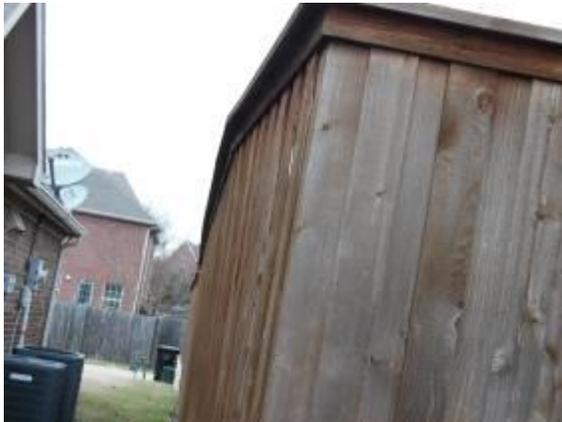
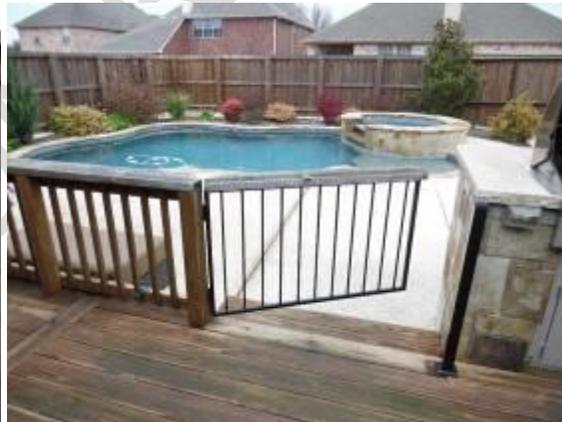
I. Other – Comments: West side fence bows. Pool gate should be self-closing. Outside gas grill would not light, the igniter would not click when pushed. The gas did turn on.
