PROPERTY INSPECTION REPORT

Prepared for: John and Jane Doe

Address: Any Town, Texas

By: Ron Lane Home Inspections, PLLC TREC # 21713

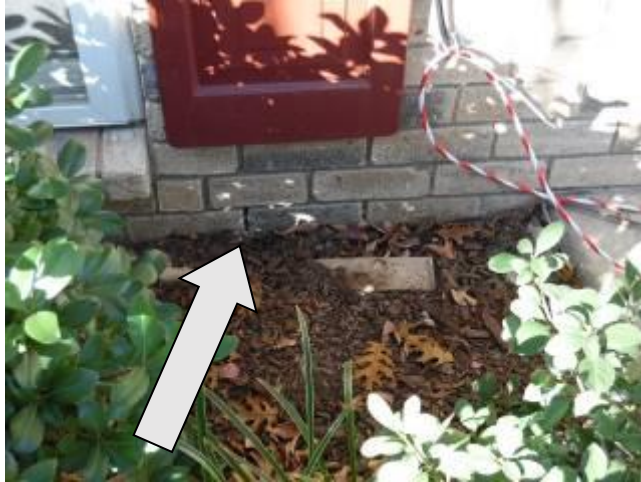
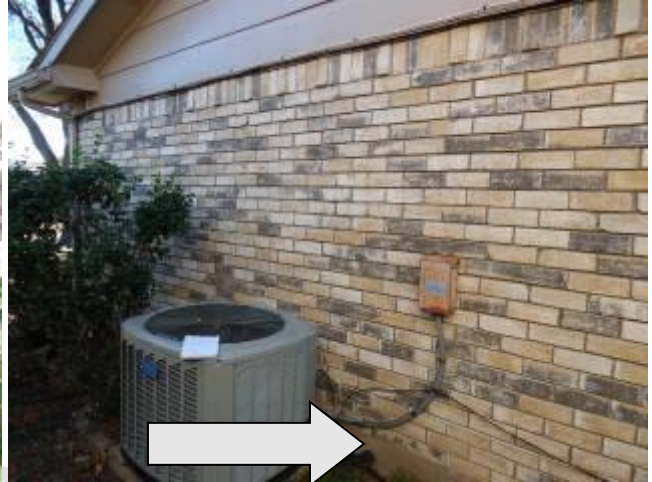
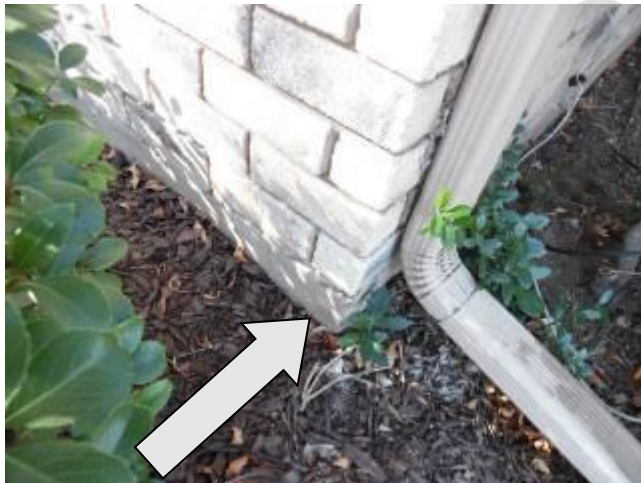
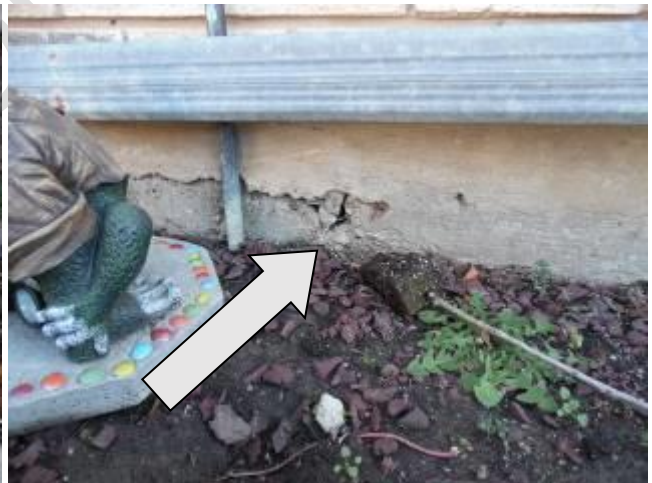
A. Foundations

Comments: Slab on grad foundation appears to be performing its intended function. Could not see much of the foundation as the top of the foundation was at ground level. Should see a minimum of 4-6 inches of foundation. West side post tension cables need to be re-pointed with plastic based cement. Hair line foundation crack near the A/C unit where the lines go into the foundation.

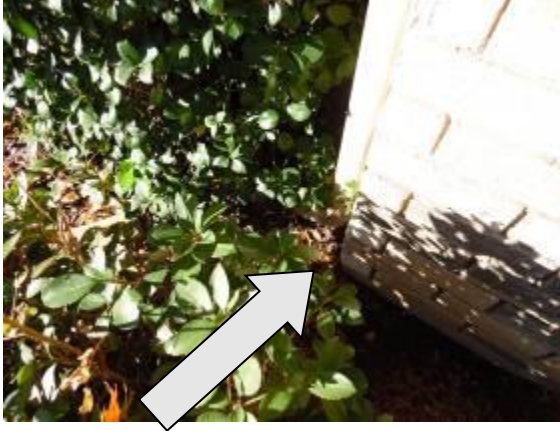
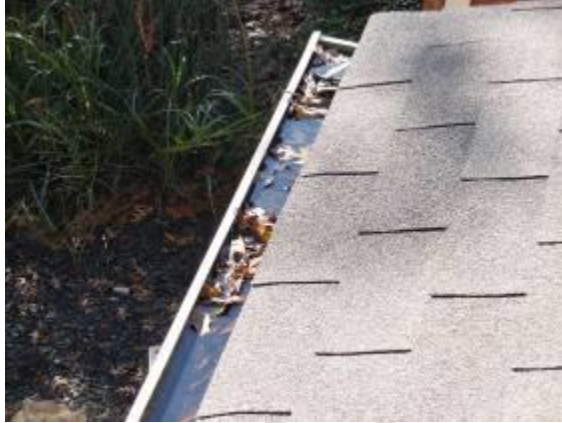
B. Grading & Drainage – Comments: Slope around house should drop around 6 inches or more per 10 foot away from house. Many down spouts did not have diverters to keep water away from the foundation. Front gutter stopped up and full of water.

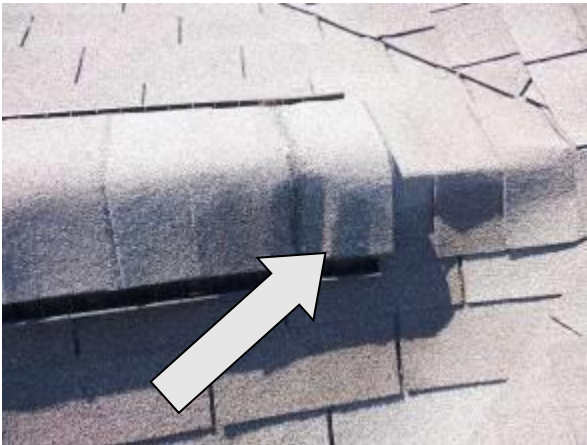
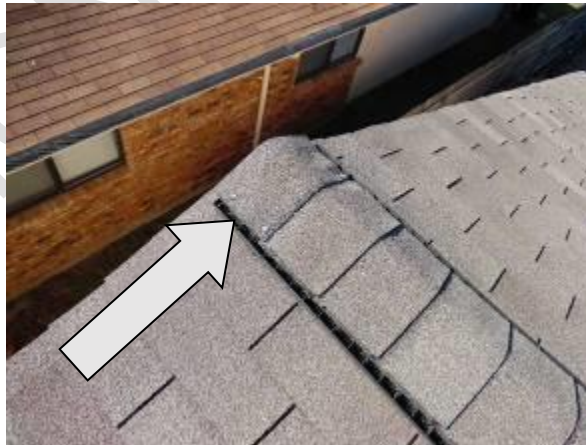
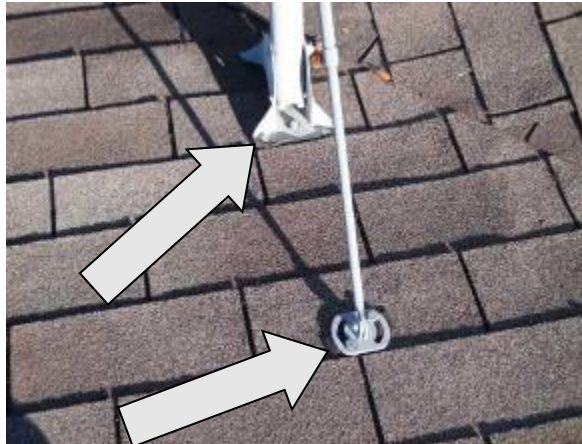
C. Roof Covering Materials

Comments: Roof ridge shingle end nails and Direct TV mounting bolts should be calked. Patio cover was patched.

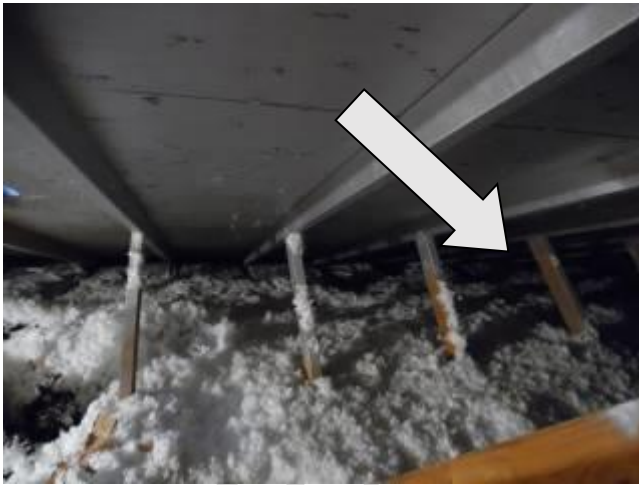
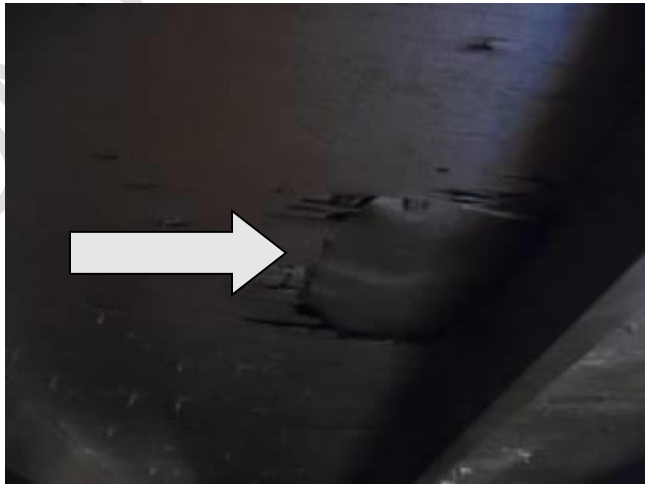
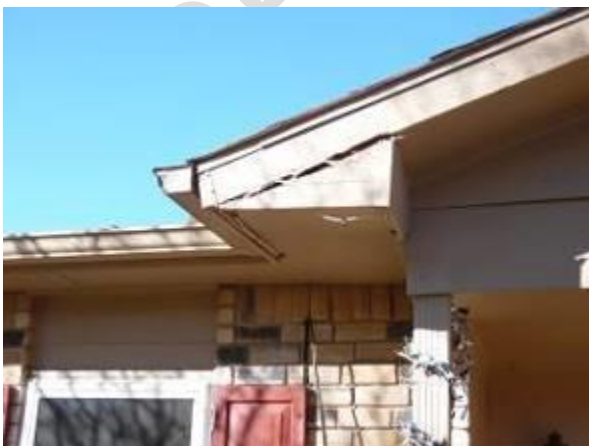
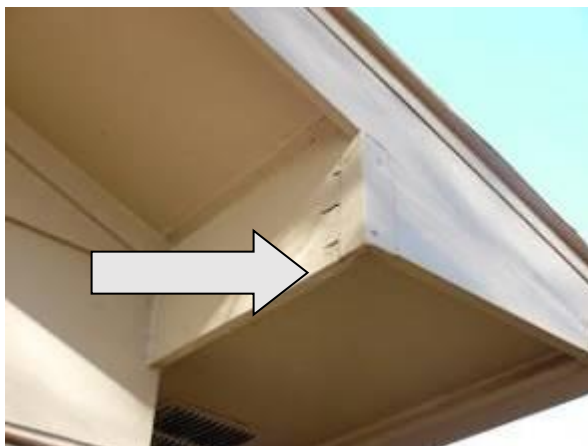
D. Roof Structure & Attic

Comments: Insulation should be 12-14 inches. New white blown insulation was not applied evenly, it was less at outside edges. Turbine vent hole patched with rolled roofing, vents still on roof. Remove patch for better ventilation. Fascia separating above front door and soft wood on north front fascia.

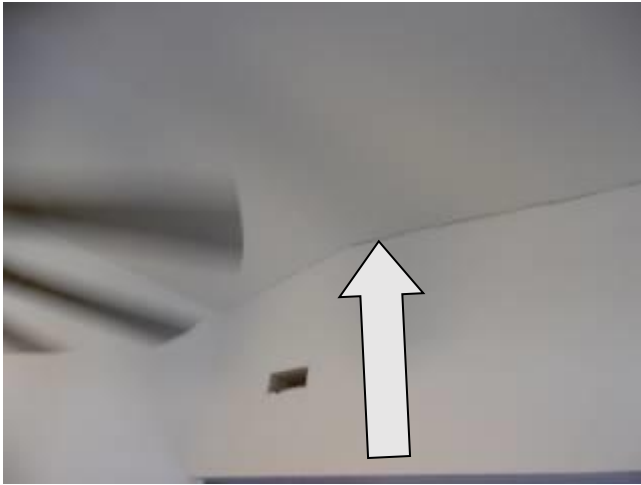
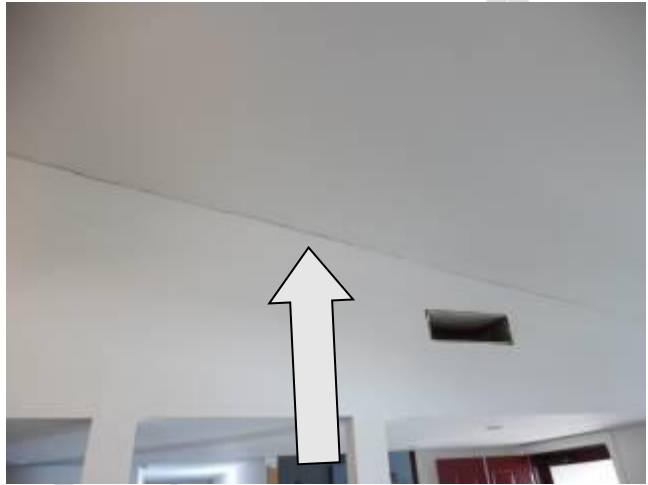
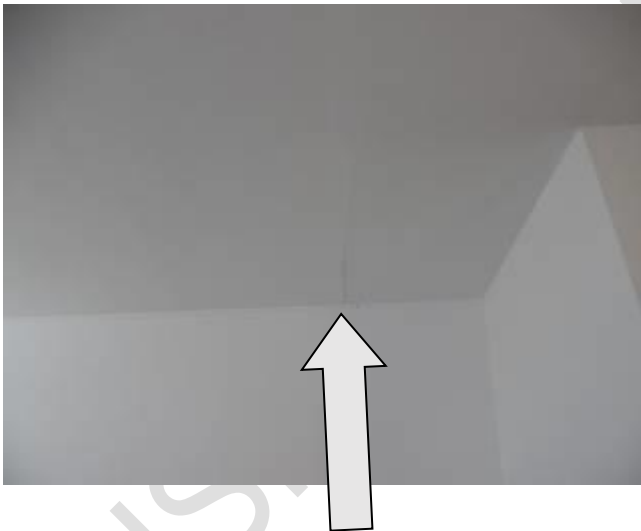
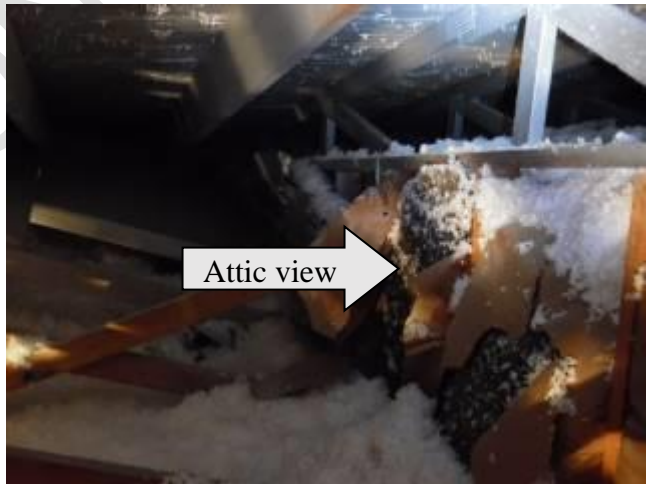
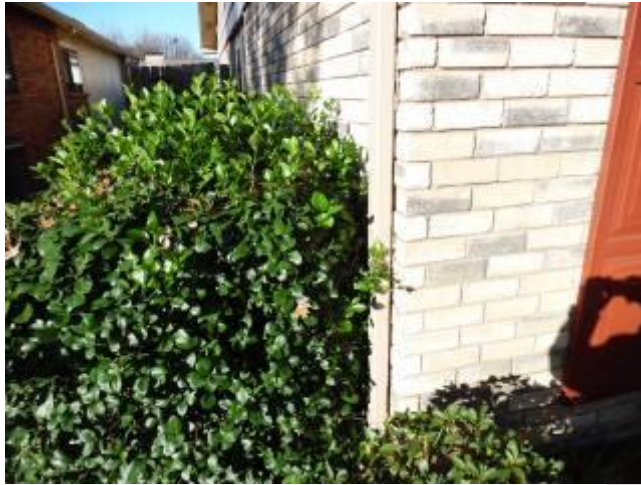
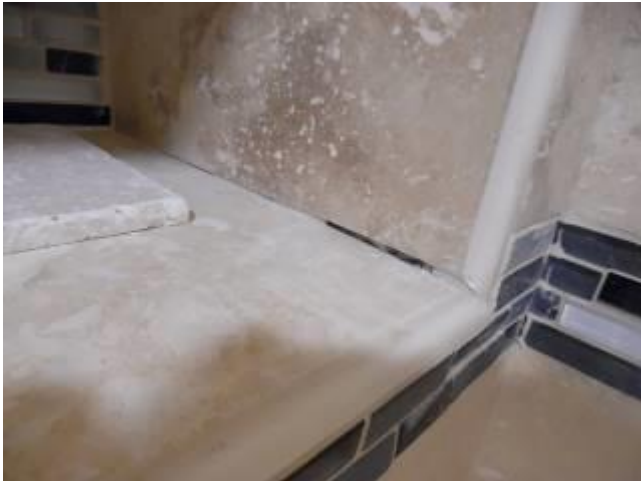
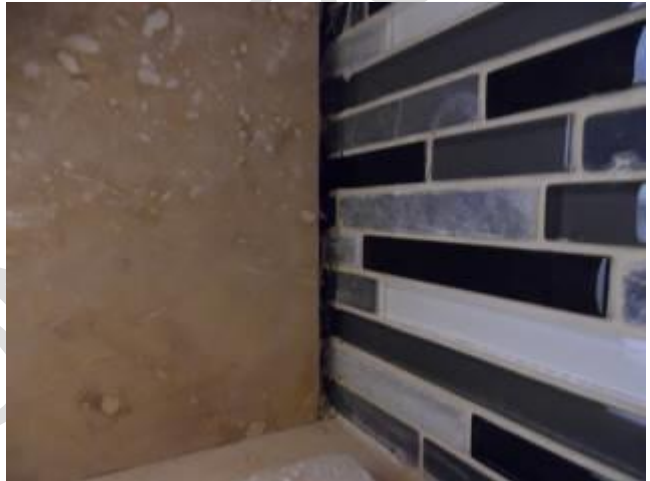
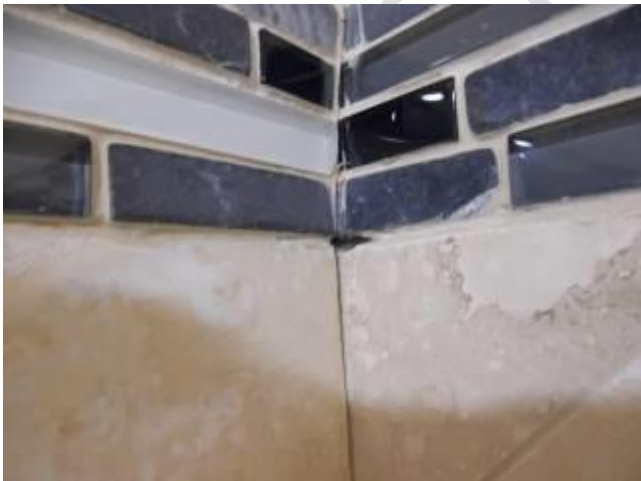
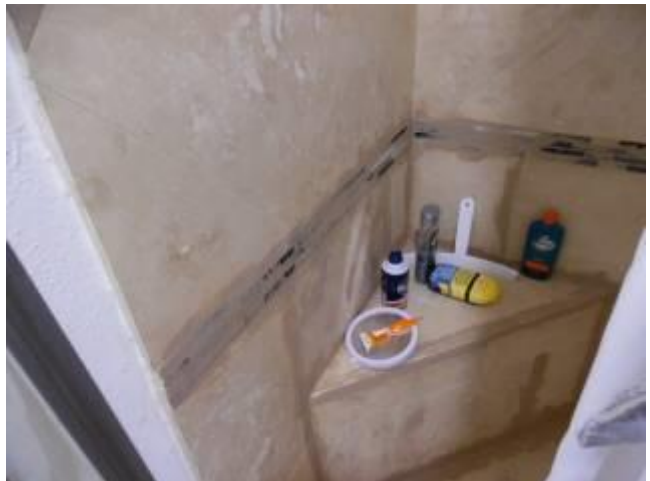
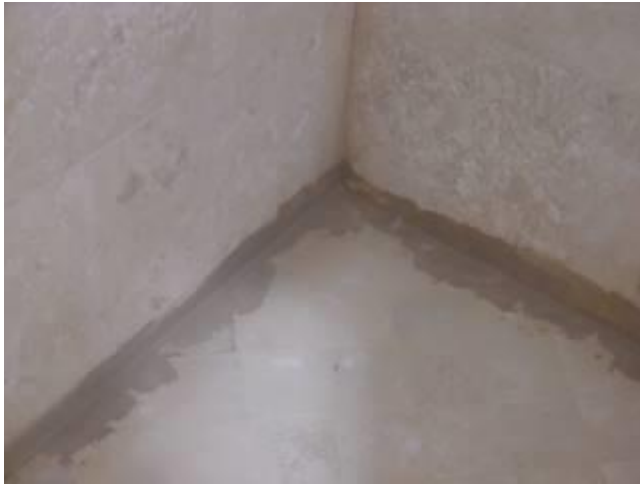
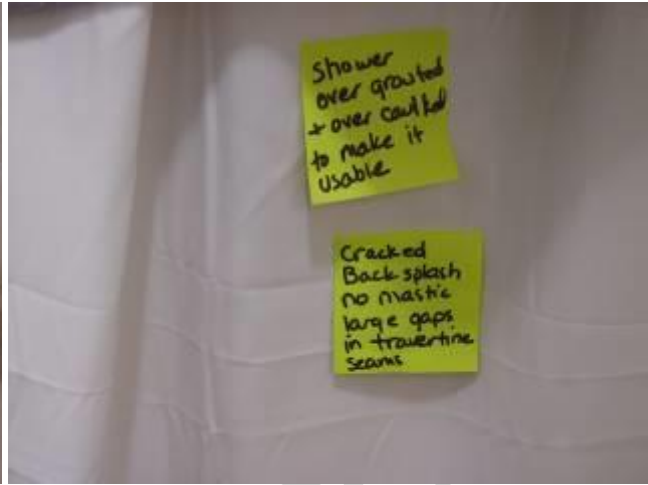
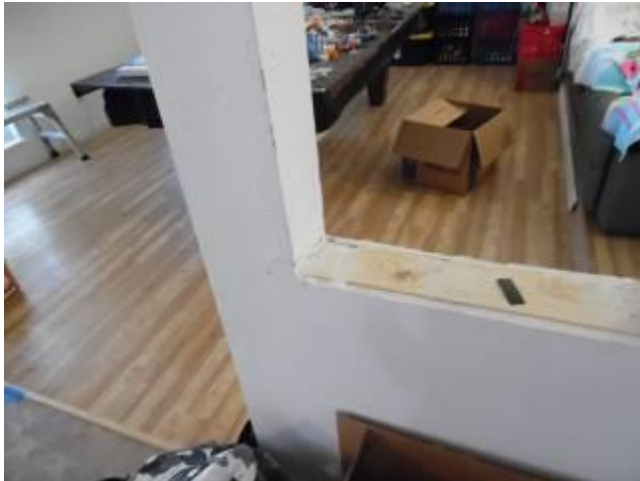
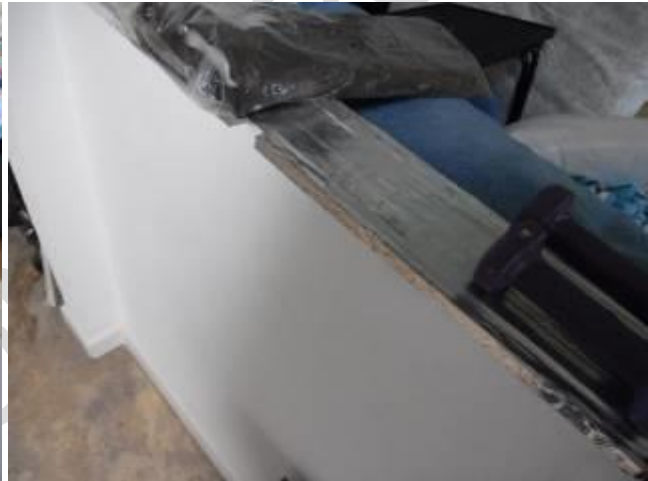
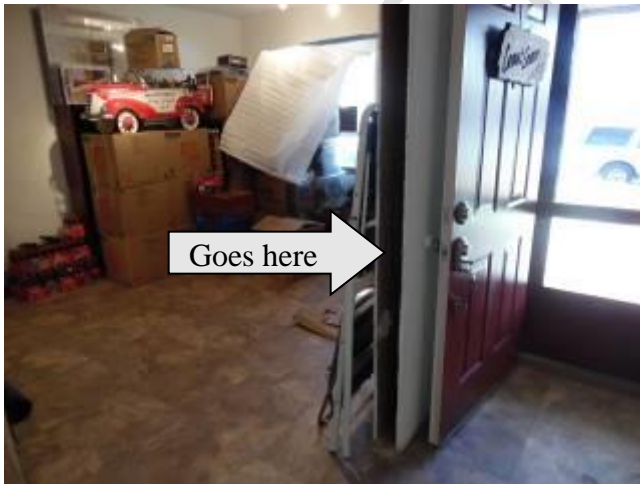
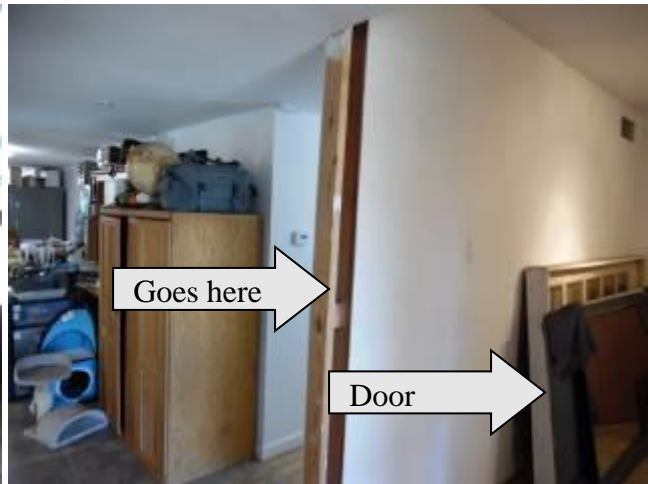
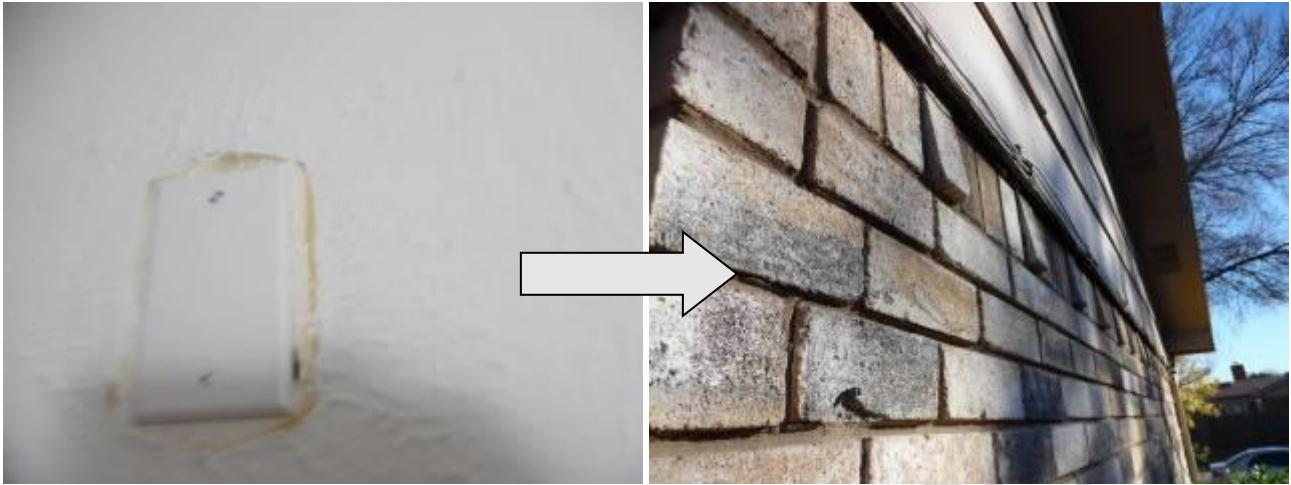
E. Walls (Interior & Exterior) – Comments: Vaulted ceiling wall structure has drywall separation. Shrubs should not touch building. South side siding has slight separation at the bricks. South siding by gate has water penetration near the ground. North side siding has water damage and is soft to the touch. Windows and brick ledges need repointing. Bathroom sinks missing back splash and tile grout missing or needs refinishing in showers. Many rooms in the house are missing baseboards. Wall pass-through shelves missing in front rooms. Study door has not yet been installed. Hole for old alarm in hall not completely covered by cover. Mortar cracks around home needs repointing.

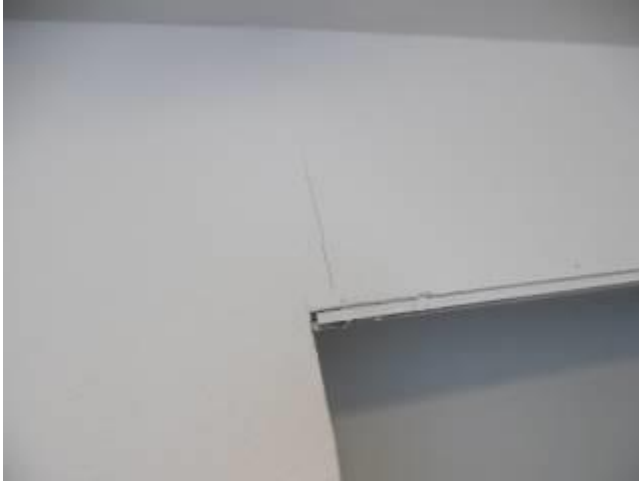
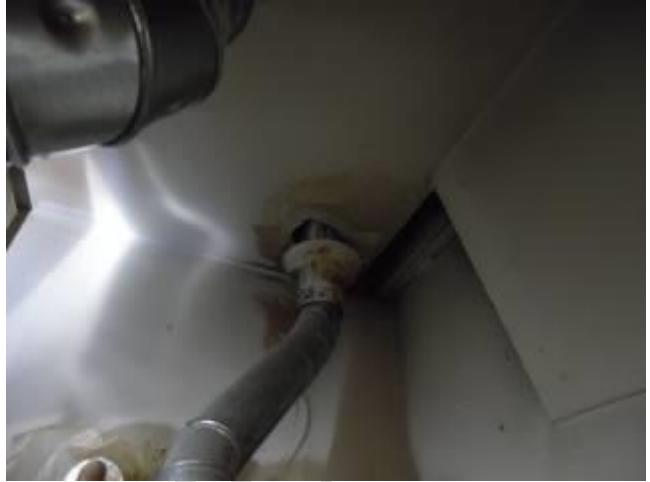
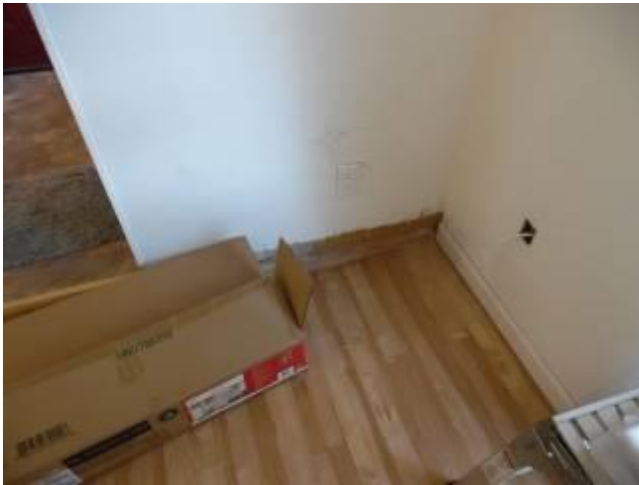
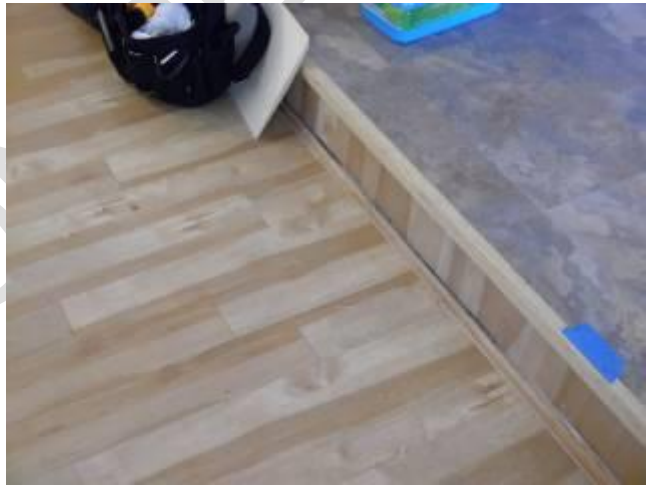
F. Ceilings & Floors – Comments: Drywall crack above north east bedroom closet. Water leak residue above water heater. Floor slope in game room near front door corner. Most baseboards and trim missing throughout house.

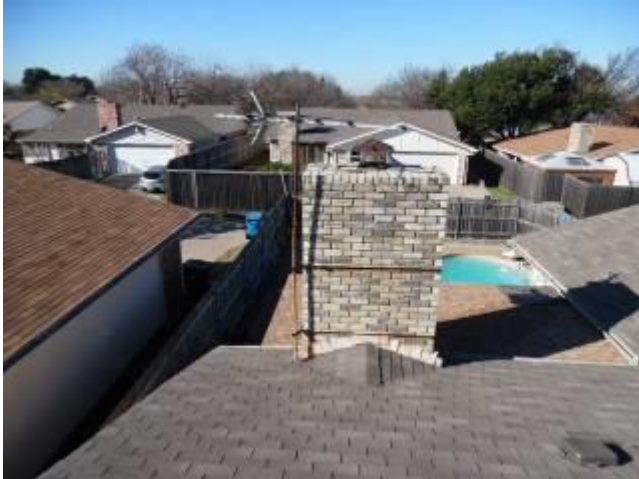
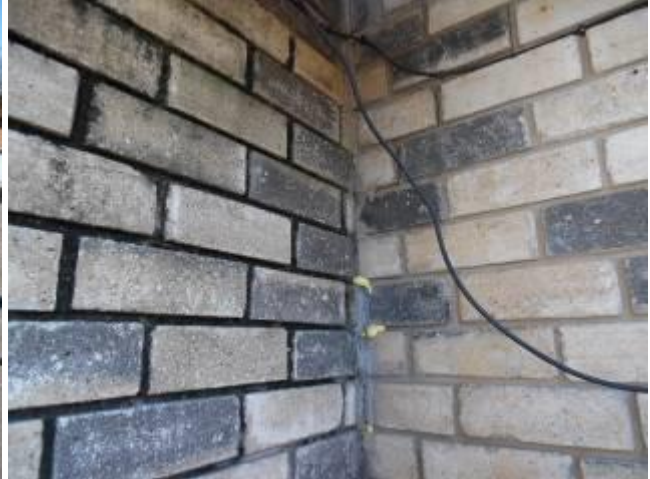
J. Fireplace/Chimney - Comments: Flue damper would not move, back center fire brick had crack and top right fire brick had a corner missing with a possible hole. Antenna should not be attached to the chimney. Small cracks and expanding foam in chimney mortar.

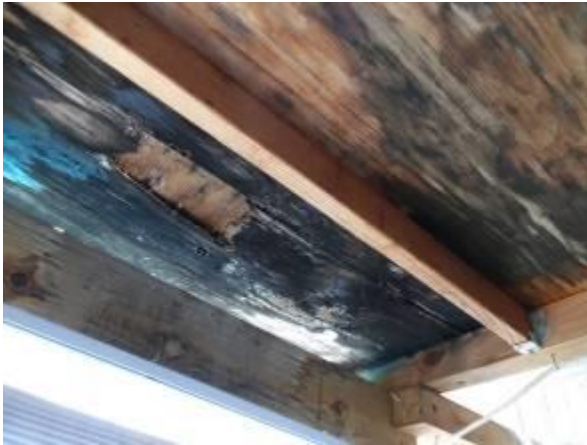
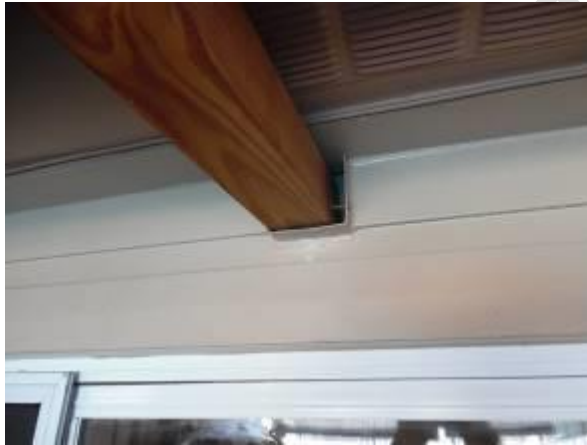
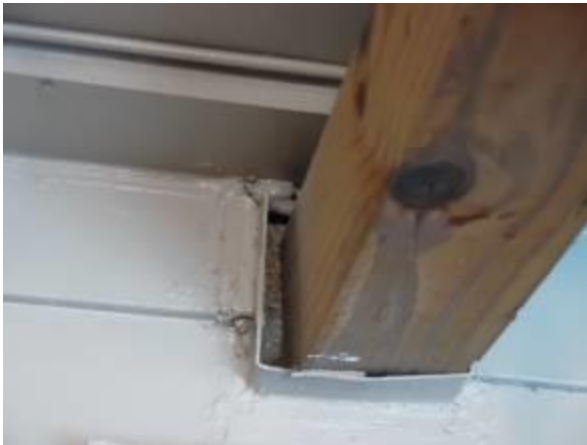
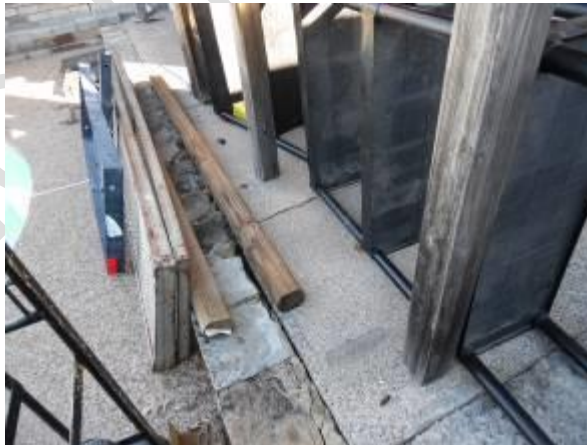
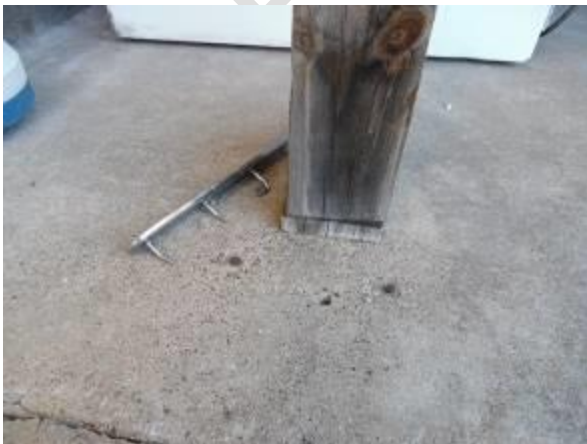
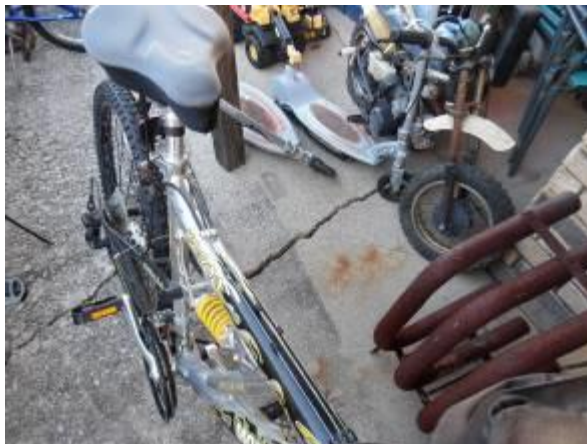
K. Porches, Balconies, Decks, and Carports – Comments: Back porch roof appears to have been under a grill and has charring, roof shingles were patched over. Wood support posts are not mounted, should be on metal support brackets keeping the wood off the slab. One post has a wood shim underneath. The metal brackets supporting the roof should be mounted to the house with proper bolts not screws into a ledger board not the frieze boards. I believe further evaluation by a professional contractor is needed. Patio appears to have been poured at different times and has multiple cracks and separations between the stones and patio that should be repaired.

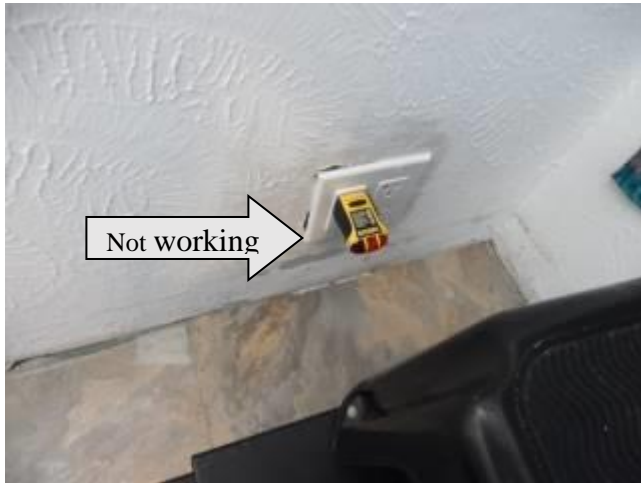
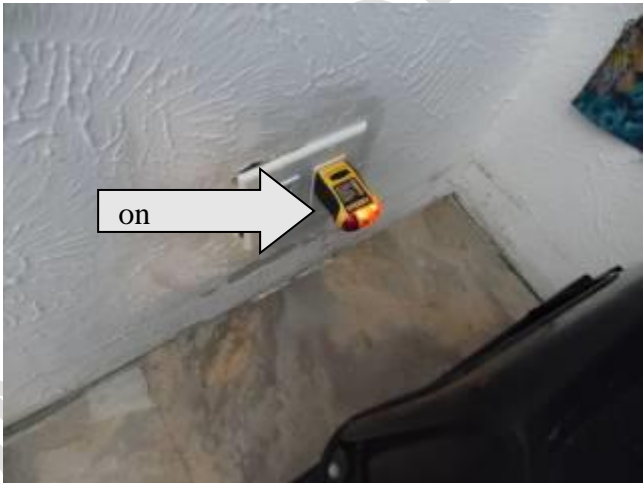
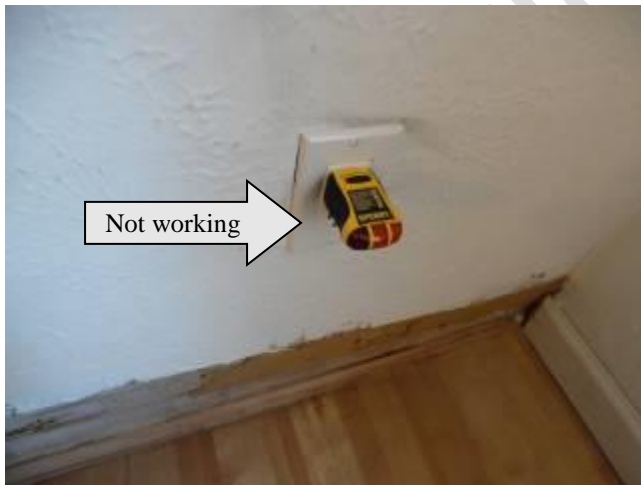
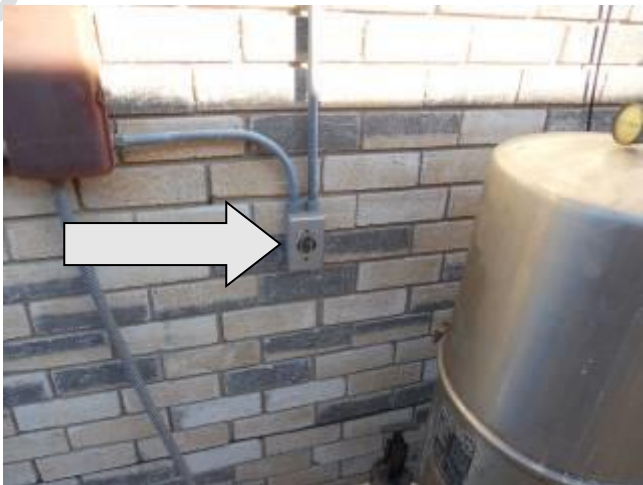
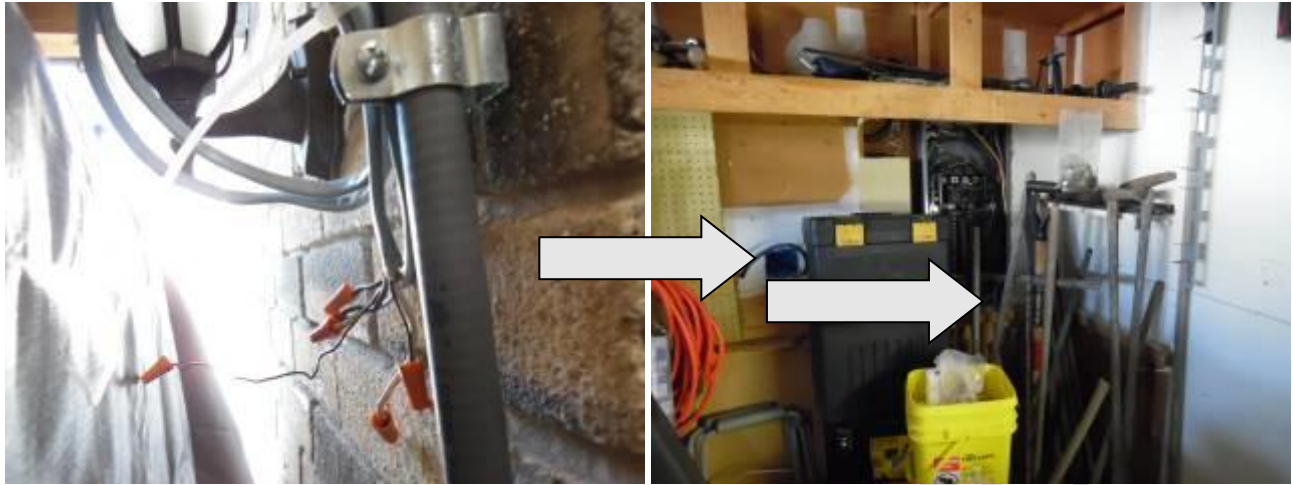
B. Branch Circuits, Connected Devices, and Fixtures

Comments: Home owner states Master bedroom bath, blue nightlight should come on when light is off and it does/did not, was not installed properly. Computer room left 2 sockets not working, right 2 worked. Inside plug by game room front door not working (may be connected to light switch (it was)). Smoke alarms should be in all bedrooms and common areas. Weather cover missing from condenser unit switch. Exposed wires on patio and at breaker box does not seem to have power.

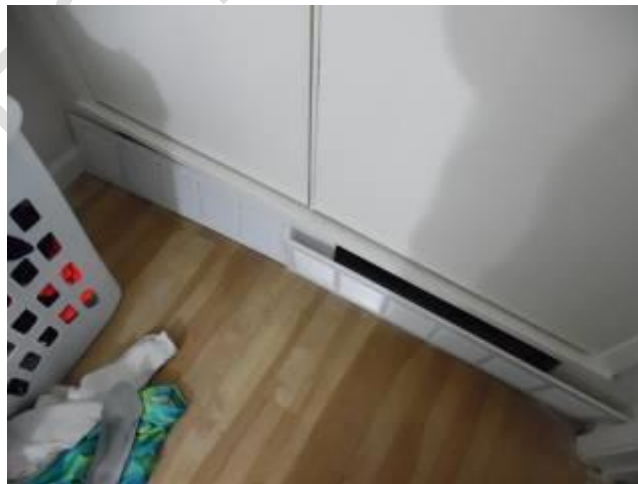
C. Duct System, Chases, and Vents – Comments: All registers and the return air vent were not mounted, as they were being painted or being worked on. Return air vent covers do not fit and home owner states new ones were on order.

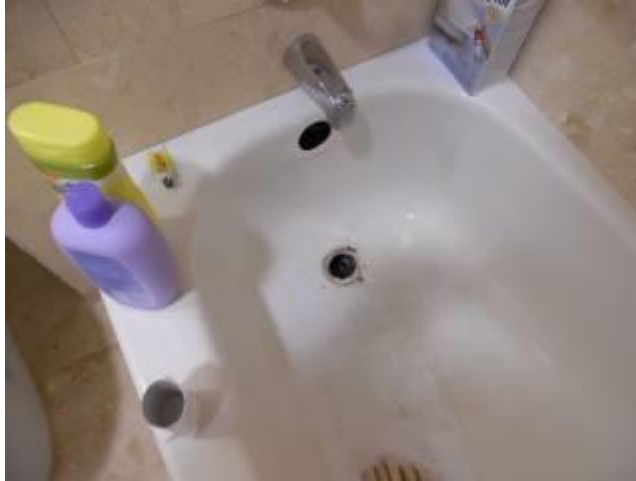
B. Drains, Wastes, and Vents – Comments: Hall bathtub missing drain and overflow stopper. (was being repaired)

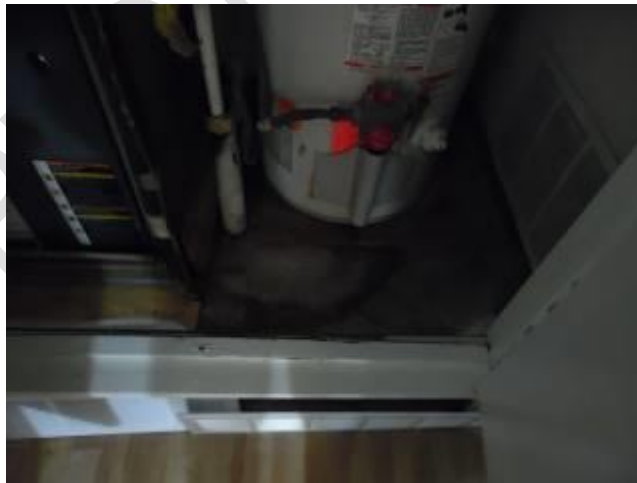
C. Water Heating Equipment

Energy Source: Natural gas
 Capacity: 50 gallon
 Comments: Missing over flow drain pan.

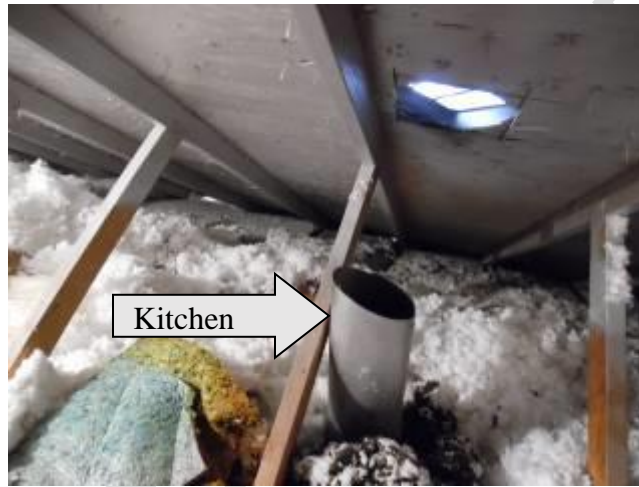
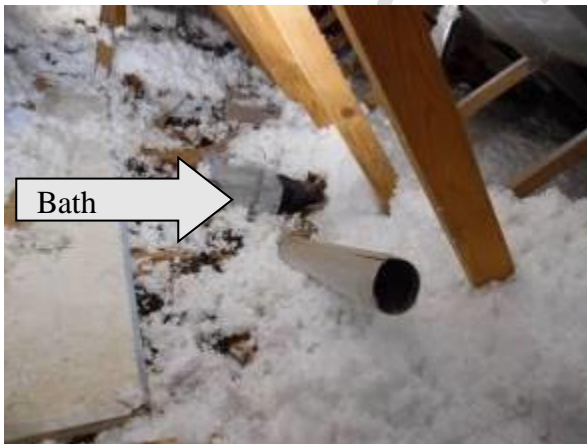
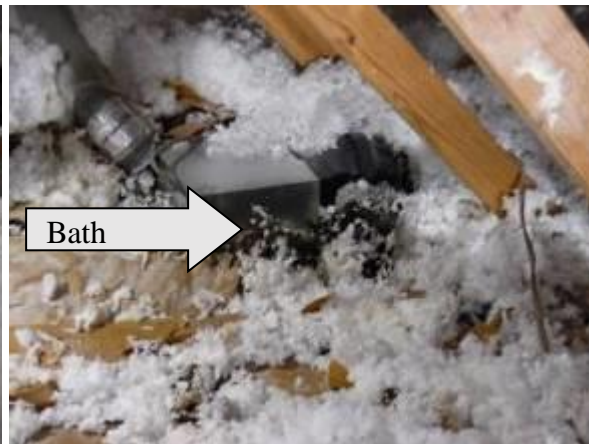
F. Mechanical Exhaust Vents and Bathroom Heaters – Comments: All exhausts vent to attic not outside.

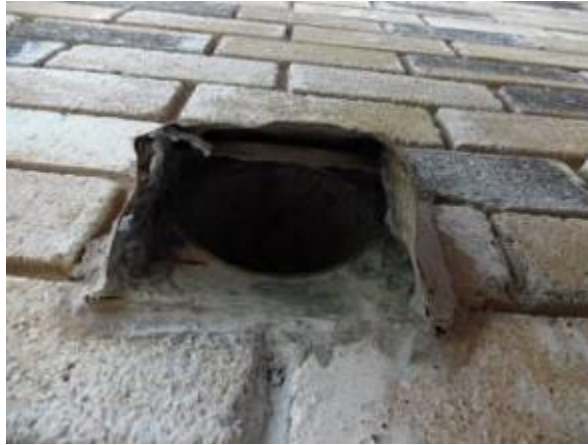
H. Dryer Exhaust Systems – Comments: Exhaust should be non-flexible and be as straight as possible. Outside vent should have a damper.

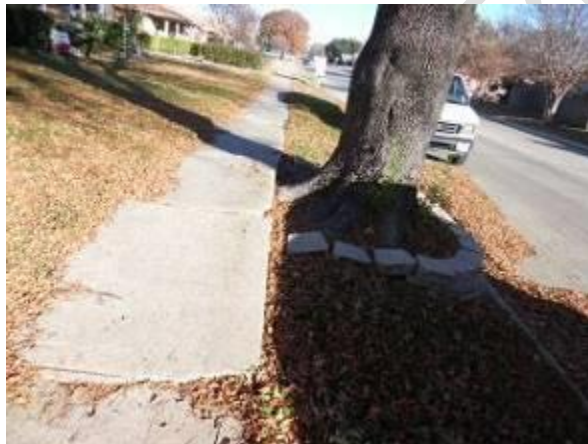
I. Other – Comments: Missing door alarm to backyard pool area. Pool gates should self-close and latch. Front sidewalk has cracks and is not level.
