PROPERTY INSPECTION REPORT

Address: My Texas 75000

By: Ron Lane Home Inspections, PLLC TREC # 21713

2/10/2016

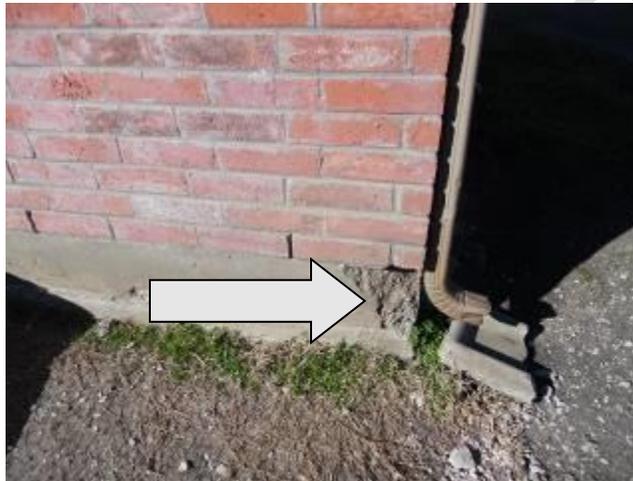
Comments: Slab on grad foundation appears to be performing its intended function and immediate significant repair(s) are not evident. Corner pop on North West corner does not appear to be structural.

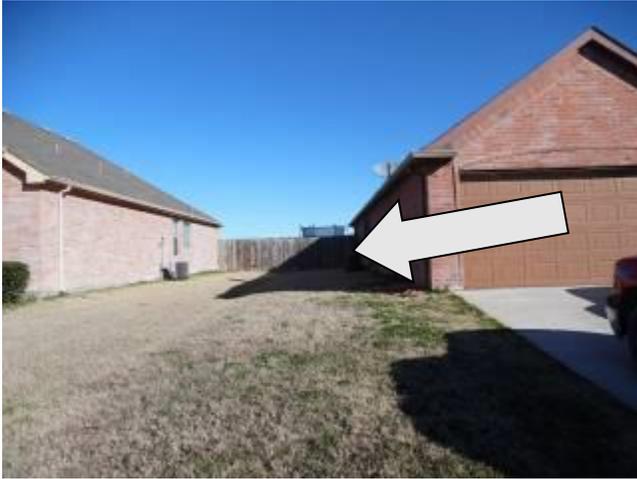
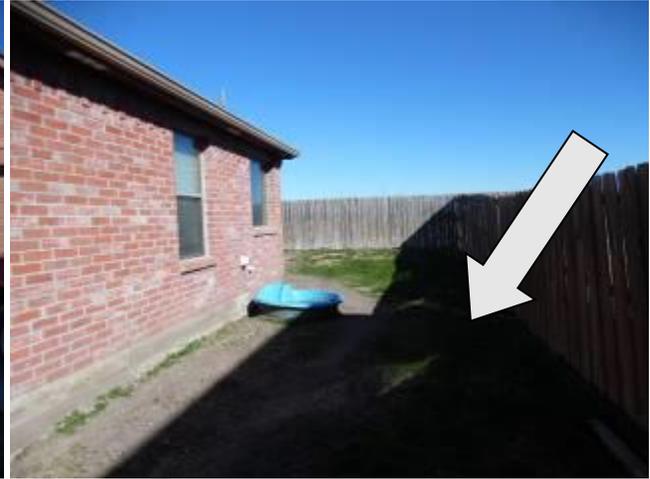
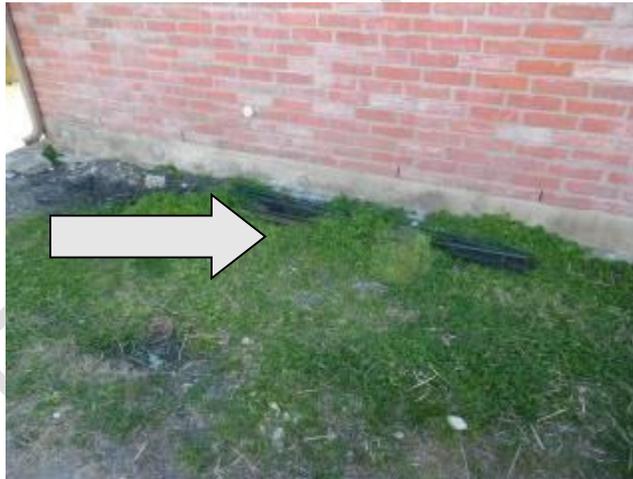
B. Grading & Drainage – Comments: North, East and West side of house the Inspector recommends re-grading around the home perimeter or possibly a French drain system to provide positive drainage away from the foundation. Dog digging holes in the back yard should be filled in.

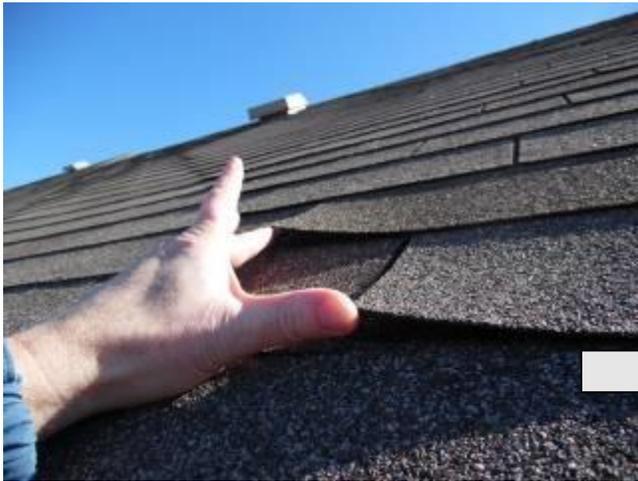
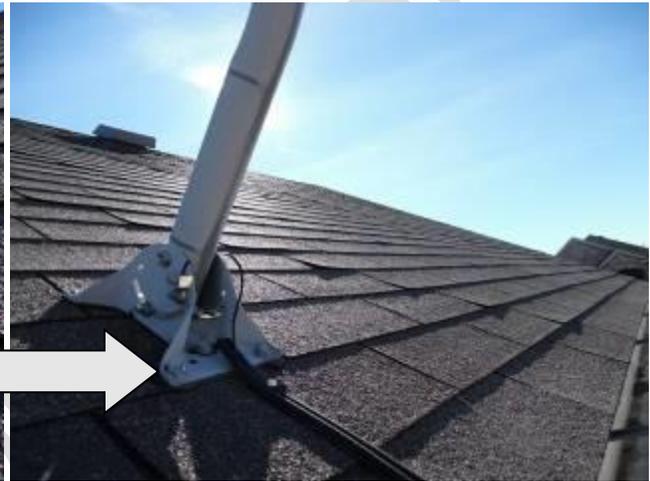
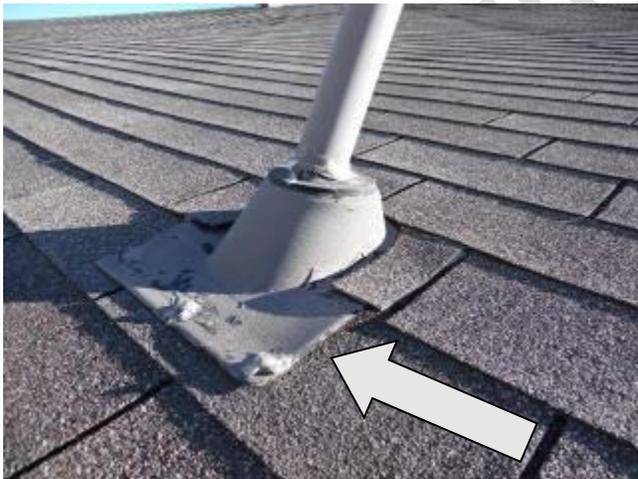
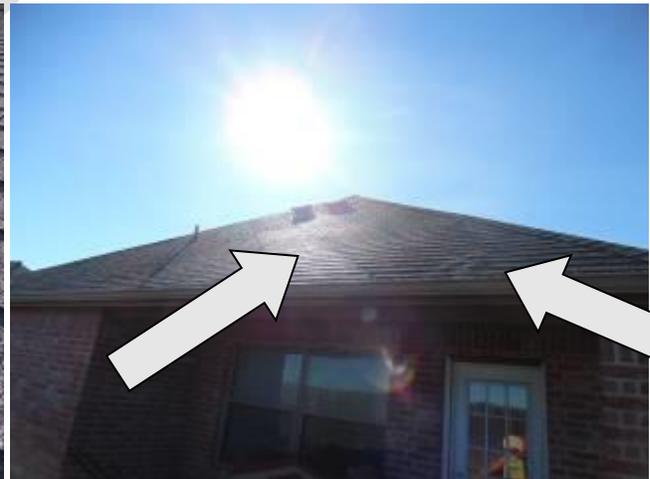
Comments: Many rows of shingles have corners that are not secure. Dish satellite bolts should be chalked and vent flashing should be better secured and chalked. A qualified roofing specialist should be consulted about these issues.

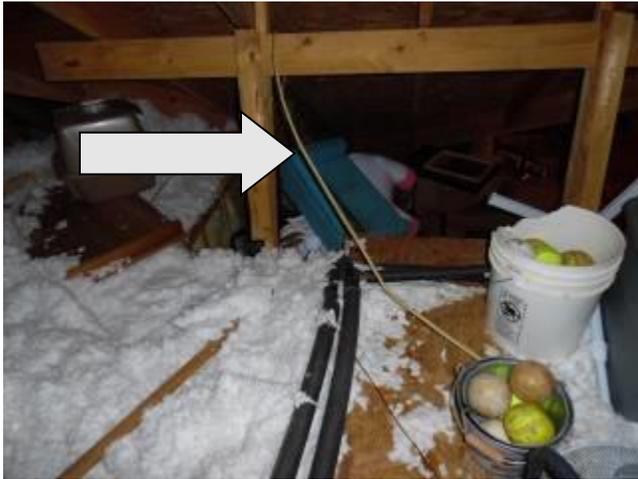
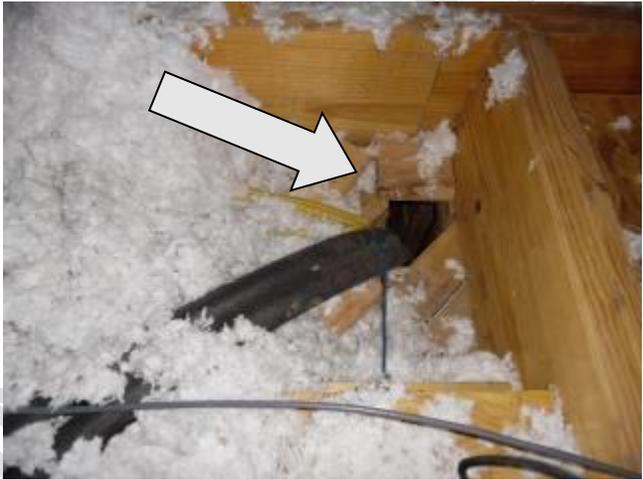
Comments: Electric wire should not be in the attic pathway to the A/C unit and should be secured. Void for water and electric lines should be fire resistant at the conversion point from the first floor to the attic and be insulated. Turbine vents should be installed for better attic ventilation. The gable wood trim over the garage should not touch the shingles should have a 1-2-inch gap.

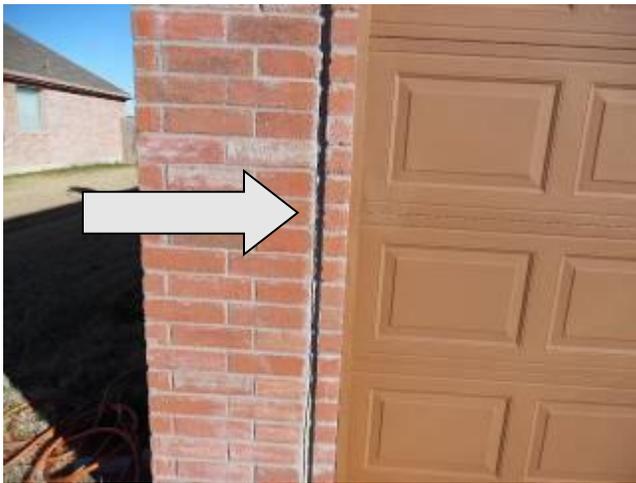
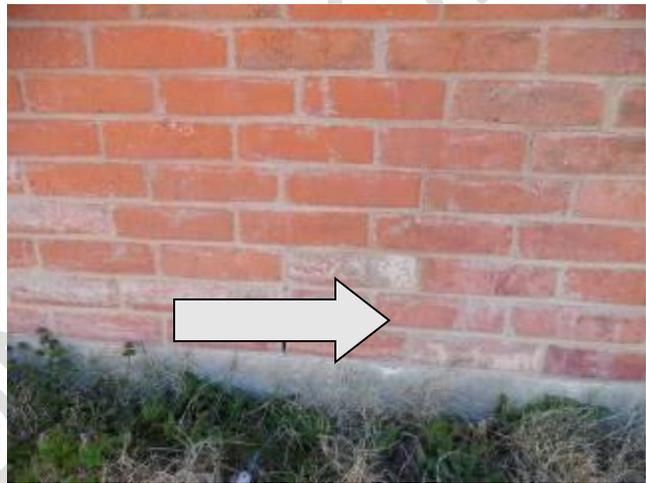
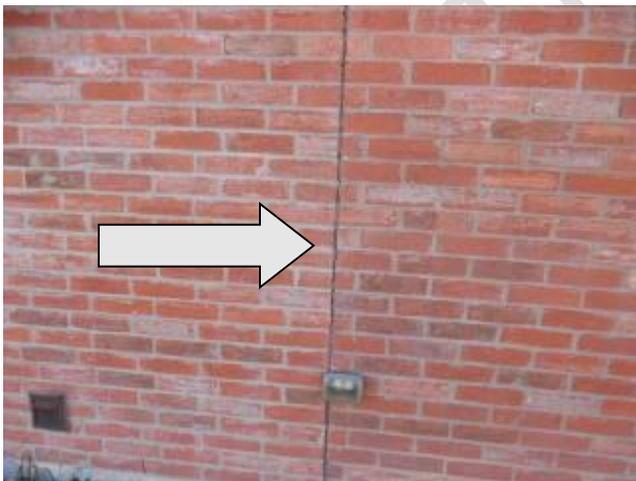
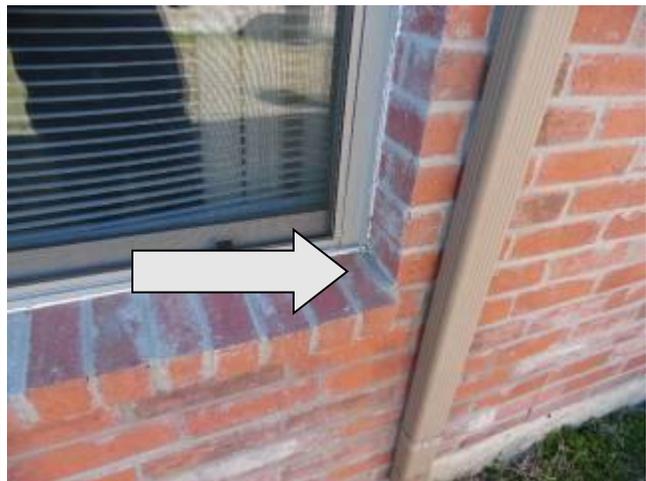
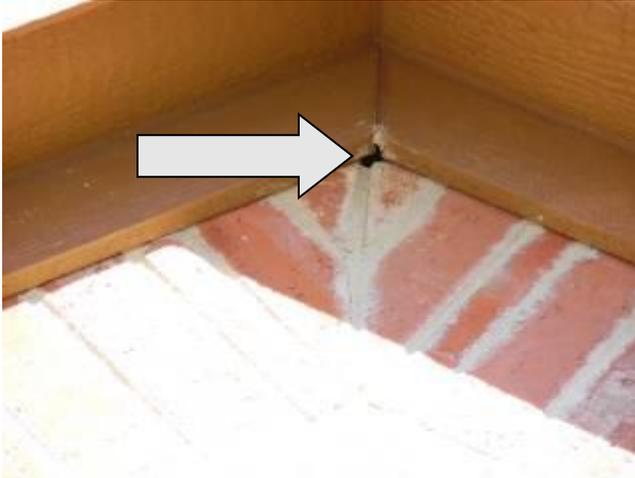
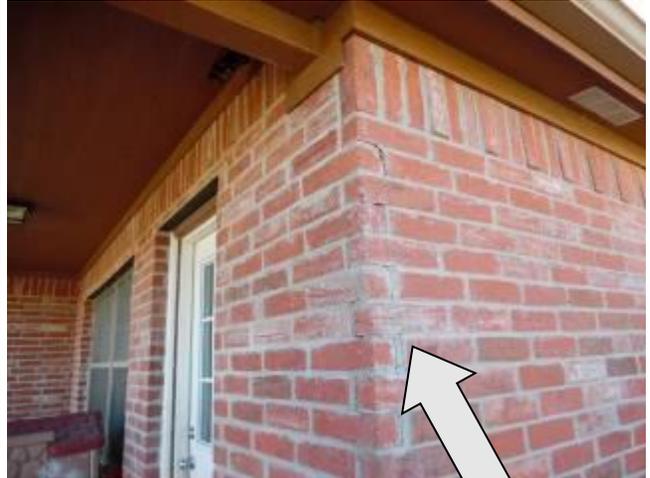
E. Walls (Interior & Exterior) – Comments: Garage brick at the trim had mortar cracks and trim should be chanked. West side had brick and mortar cracks but no evidence of foundation cracks. Expansion joint compound should be soft not hard and separating at all the joints. The West window frame and brick mortar needs repair. Small hole in front of house at frieze board should be mortared over. North West corner needs to be repointed. The inspector recommends repair by qualified contractor. Interior walls had minor cosmetic damage at the time of the inspection. Garage wall behind the water heater has a hole that was taped over and needs repair. Common bath top of tile over tub needs to be chanked.

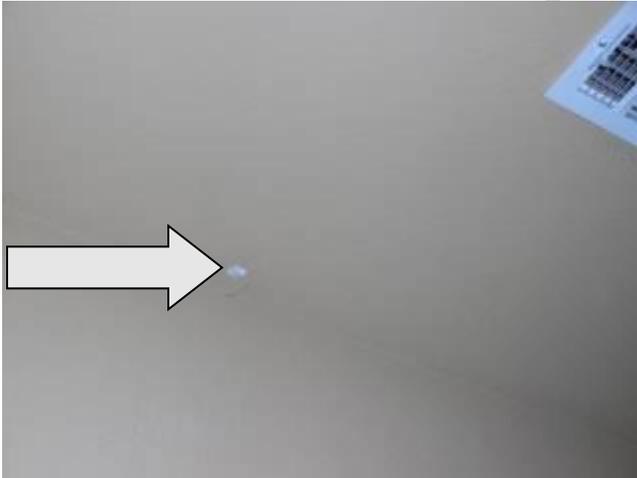
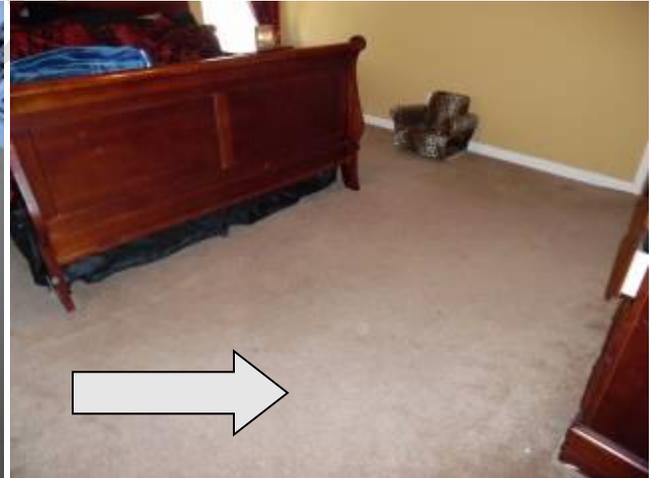
F. Ceilings & Floors – Comments: Master bed room had 2 nail pops on the ceiling and carpet needs restretched. Hard wood floor in living room appears to have pad underneath that may be worn out in spots as the floor dips down when walked on. Garage ceiling has cracks from attic storage.

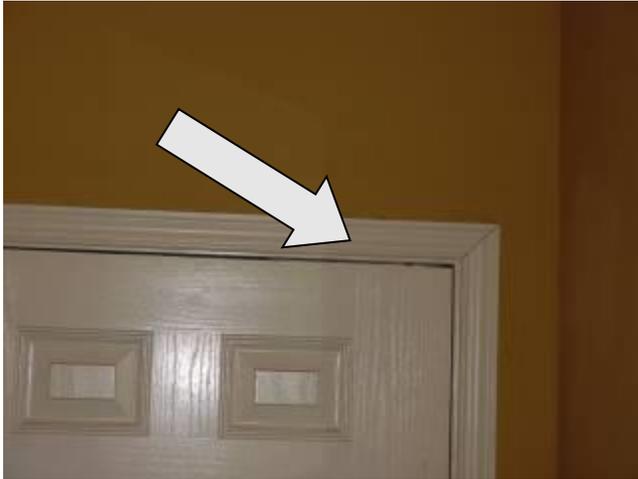
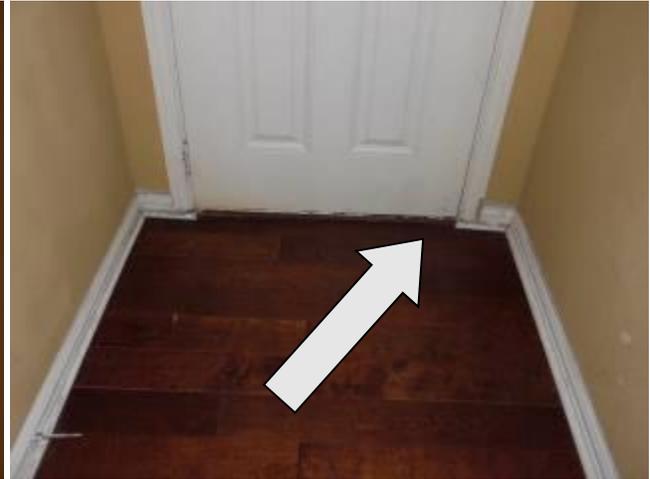
G. Doors (Interior & Exterior) – Comments: Opened and closed all doors and checked exterior locks. Front doorknob needs to be turned to shut the door and North East bedroom door will not latch closed but pulls open. Front door weather seal partly missing on the top and bottom, light shows thru. Front and back door trim has weather or dog damage.

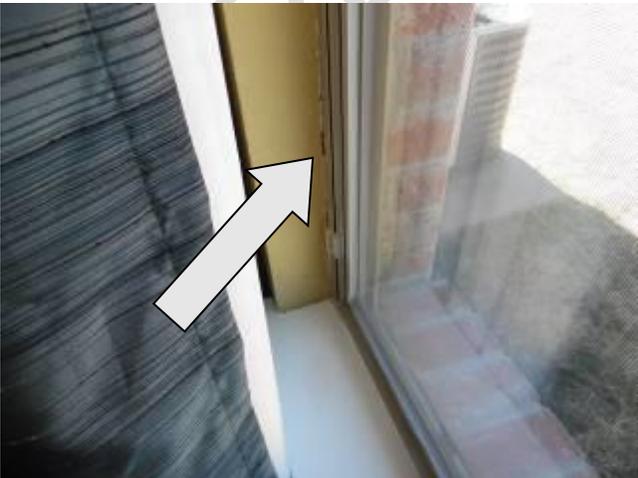
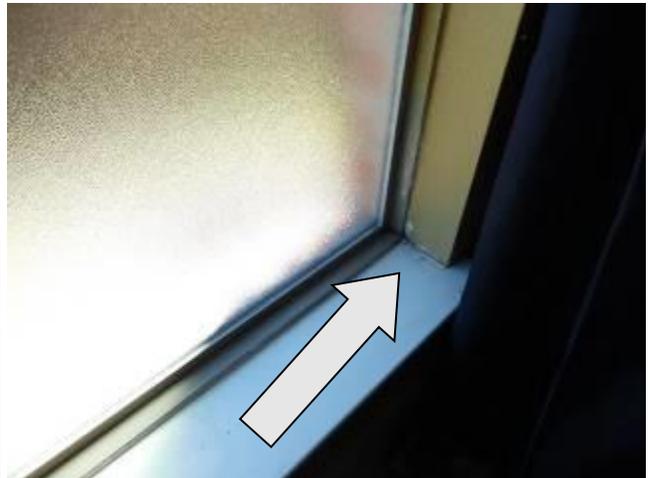
H. Windows – Comments: Opened and closed all windows and checked locks and screens. Living room screen has a hole and is bent. North East bedroom window would not stay open and needs chalking. Master bedroom south window would not stay open. North West dining window would not stay up and one lock was broken and South window needs to be chalked. Master bath lower right window needs to be chalked.

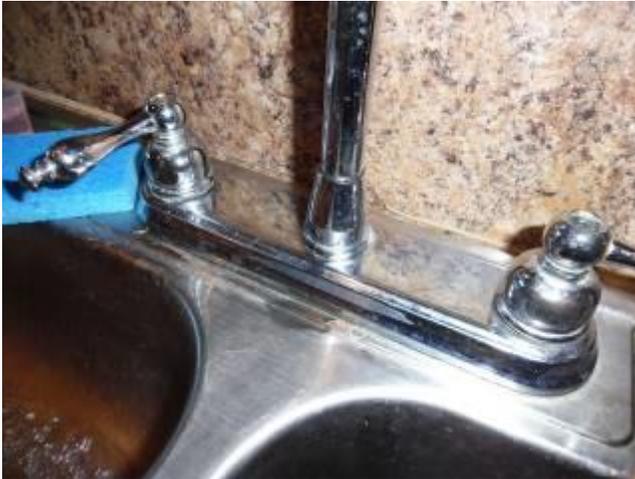
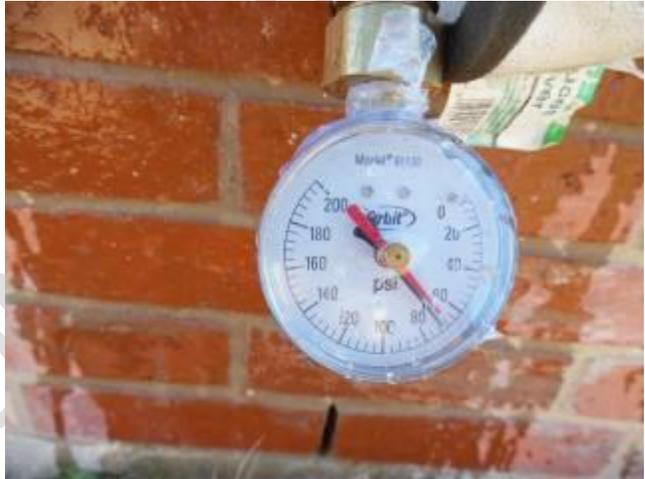
Comments: Kitchen sink faucet leaks. Water pressure should be no higher than 60 psi.

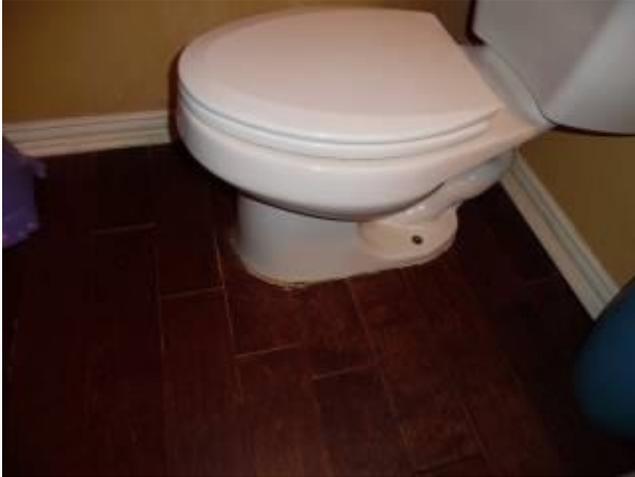
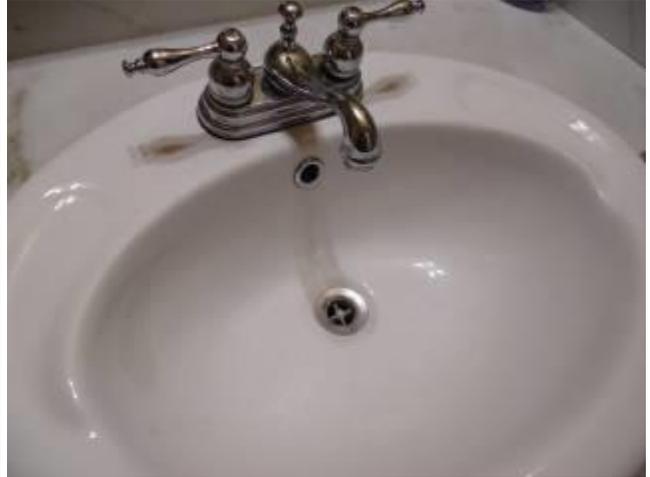
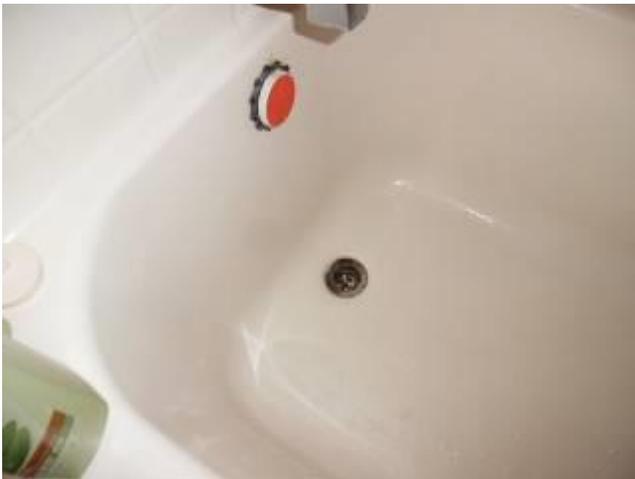
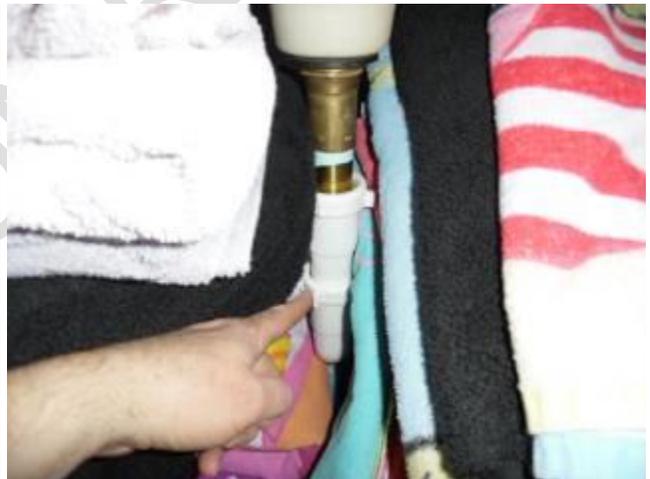
B. Drains, Wastes, and Vents – Comments: Common and master bath toilets needs to be grouted and the sink and tub had missing or broken drain plugs. Both bath rooms tub overflow drains were taped over and were missing the covers. Master bath right sink drain connections were loose.

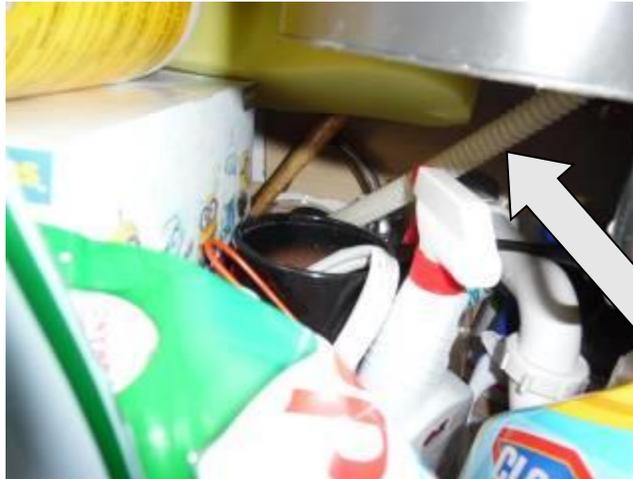
A Dishwasher – Comments: Ran through a normal cycle. Dishwasher did not appear to have a high loop for the drain to keep disposer waste from entering the washer.
