## **PRE-SHEETROCK PHASE INSPECTION REPORT**

Address: Texas 75035 9-2020

By: Ron Lane TREC # 21713

1/8/2021

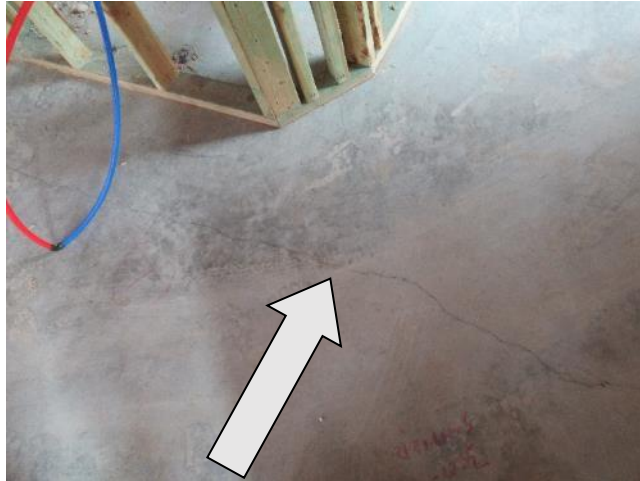
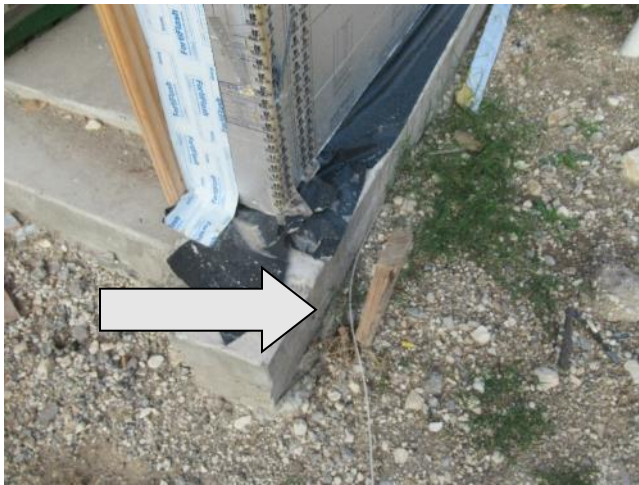
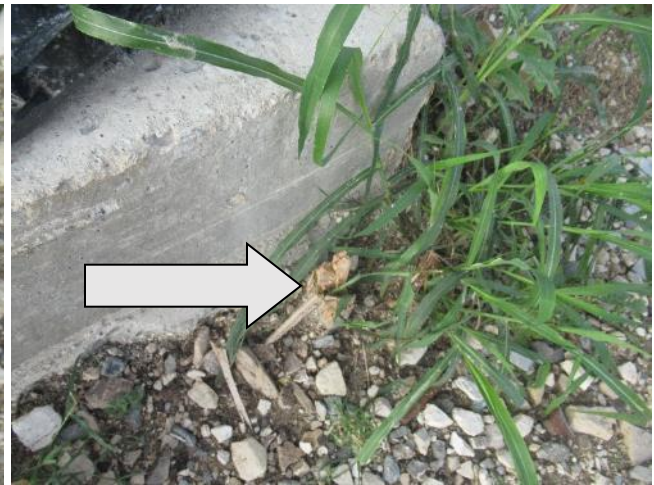
**Comments:** New Slab on grad foundation appears to be performing its intended function. Master bath had a crack. Shrinkage cracks commonly occur as newly placed concrete dries, especially at high- stress areas like corners. Shrinkage cracks are surface cracks that are not a structural concern. Wood around the foundation should be removed.

Master bath had a crack.  
Wood around the foundation should be removed.

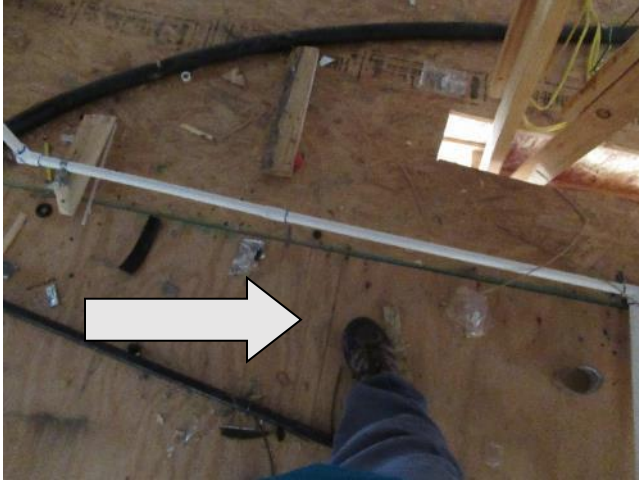
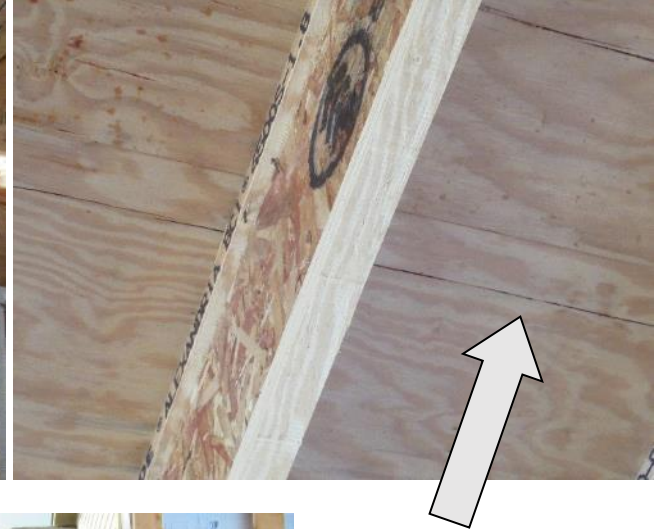
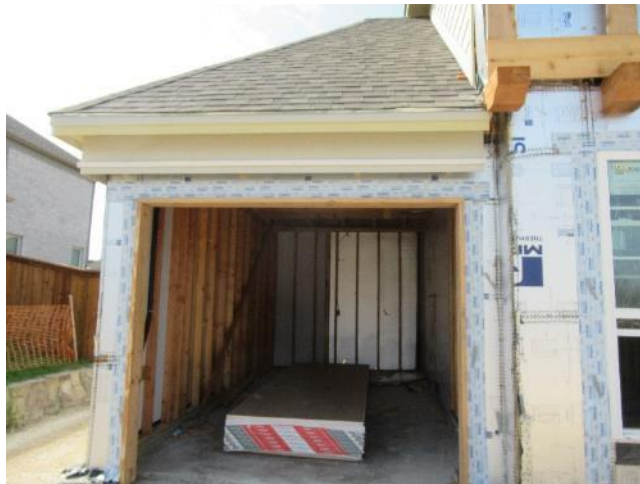
**Comments:** Plumbing vents comply with the minimum sizes per standards. Attic flooring between the A/C units had a crack all the way thru and was cracking when walking on. 1 car garage had no attic access.

Attic flooring between the A/C units had a crack all the way thru and was cracking when walking on.  
1 car garage had no attic access.

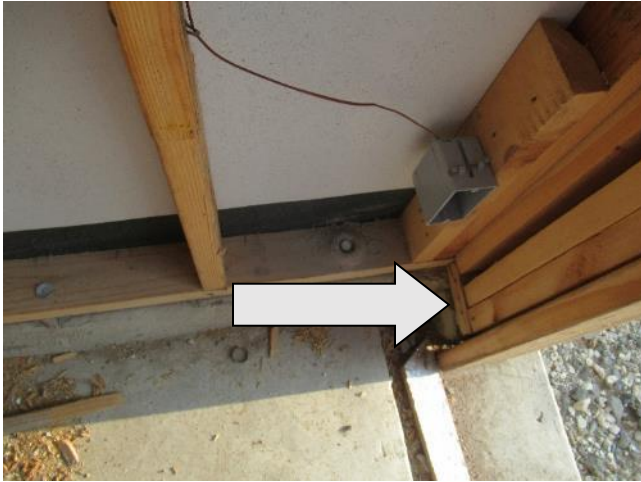
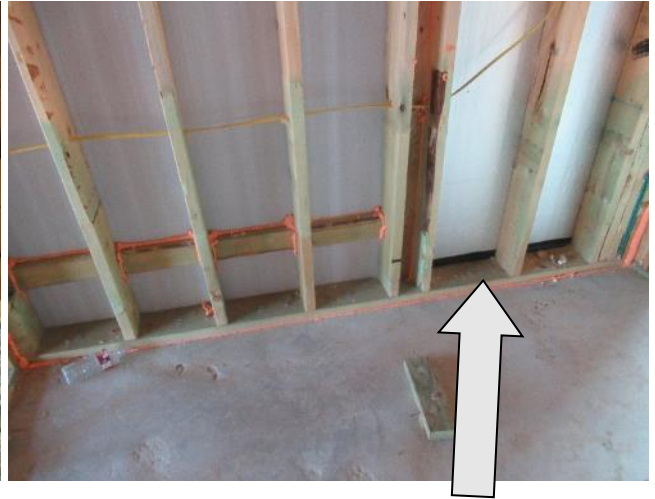
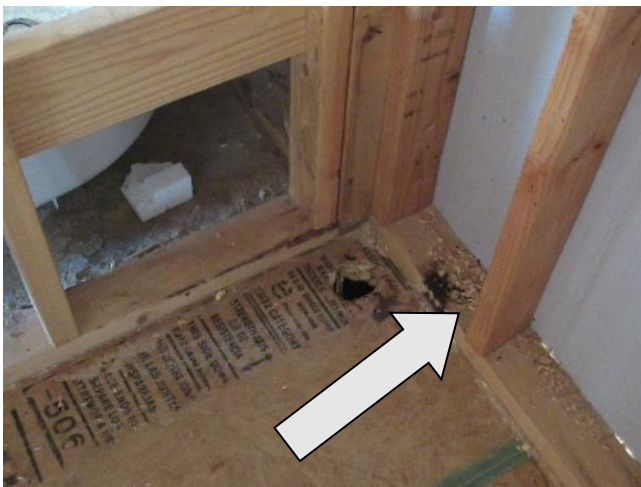
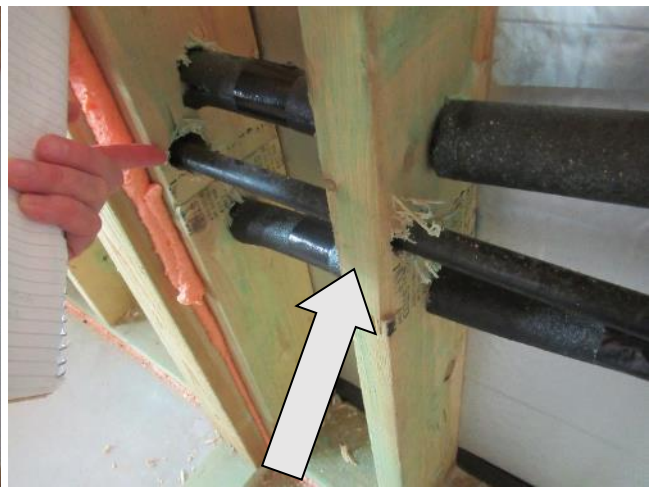
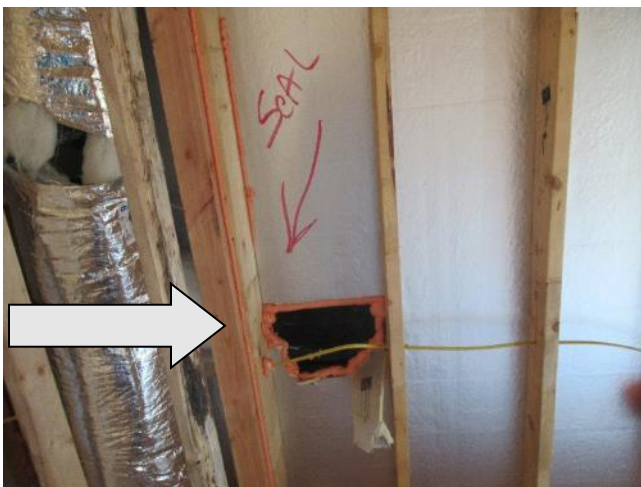
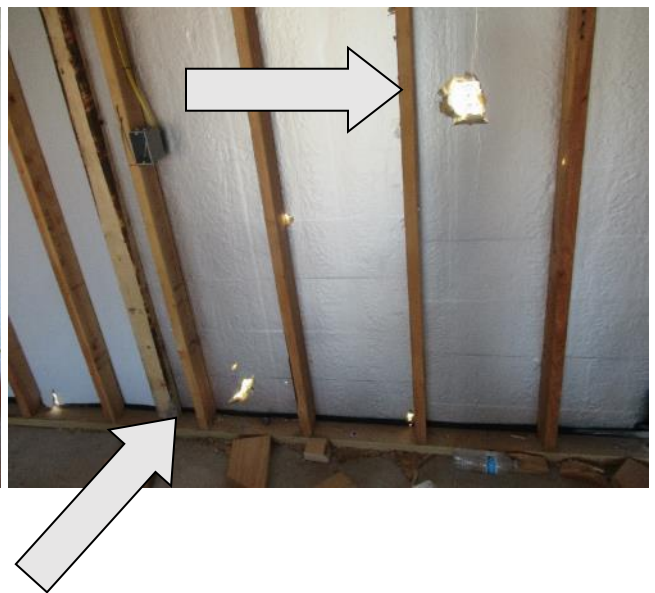
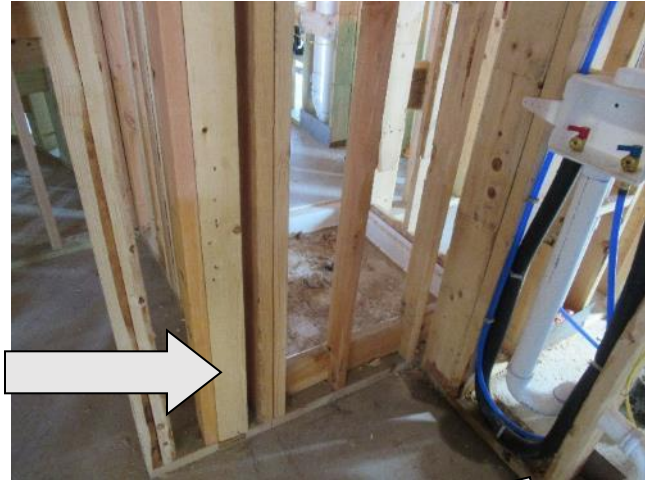
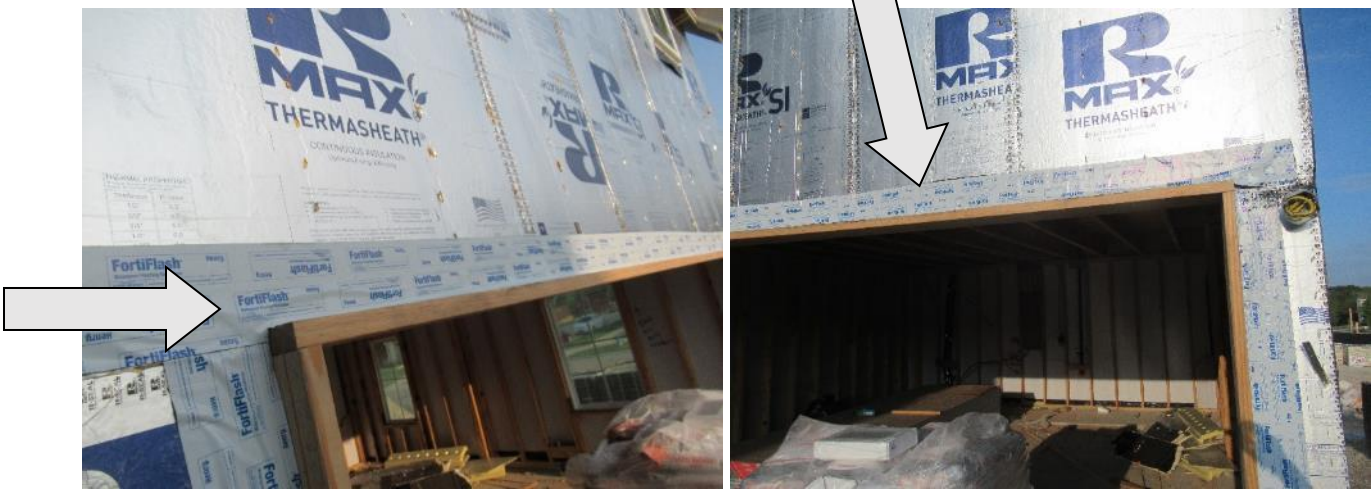
**E. Walls (Interior & Exterior) – Comments:** All outside sheaving holes should be sealed so air will not infiltrate house. Some anchor bolts were not found (not seen) at master closet and some ends. Each individual sill plate section has at least two bolts the required distance from the end of the section, per standards (some were not seen see above). Missing metal plate for plumbing and for wire protection was missing at some areas (pantry gas and some other electric wires). Some holes in the wall repairs only had expanding foam and not sheathing material. Not all ground level studs had green protectant stain on them (front bath, shower and master closet). Wood lintels over the garage doors did not have (were not seen) metal L lintels and the wood could warp/bend over time and cause brick/stone mortar cracks.

All outside sheaving holes should be sealed so air will not infiltrate house.  
Some anchor bolts were not found (not seen) at master closet and some ends.  
Each individual sill plate section has at least two bolts the required distance from the end of the section, per standards (some were not seen see above).  
Missing metal plate for plumbing and for wire protection was missing at some areas (pantry gas and some other electric wires).  
Some holes in the wall repairs only had expanding foam and not sheathing material.  
Not all ground level studs had green protectant stain on them (front bath, shower and master closet).  
Wood lintels over the garage doors did not have (were not seen) metal L lintels and the wood could warp/bend over time and cause brick/stone mortar cracks.

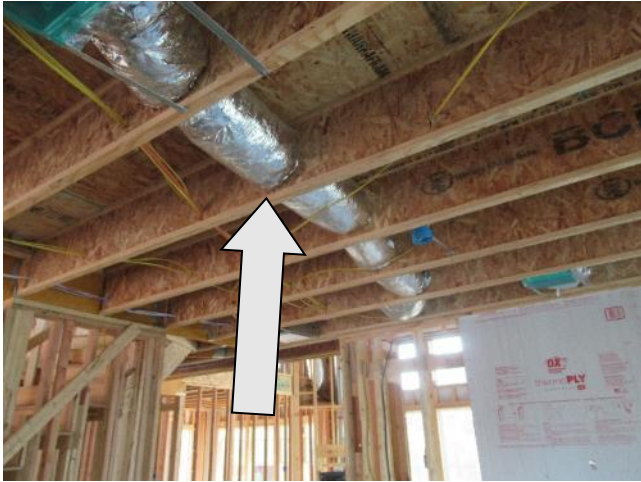
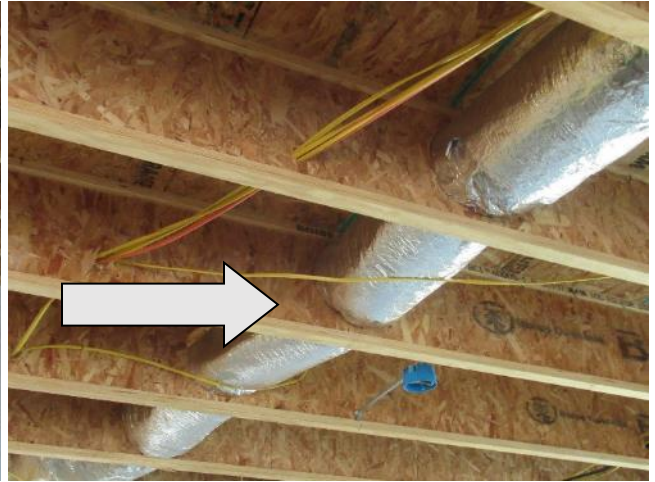
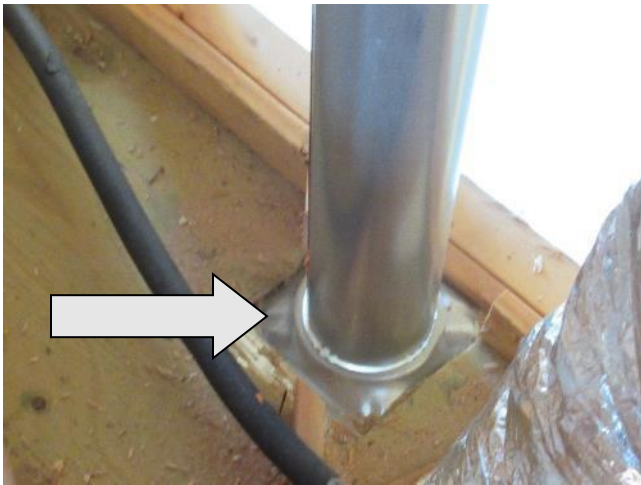
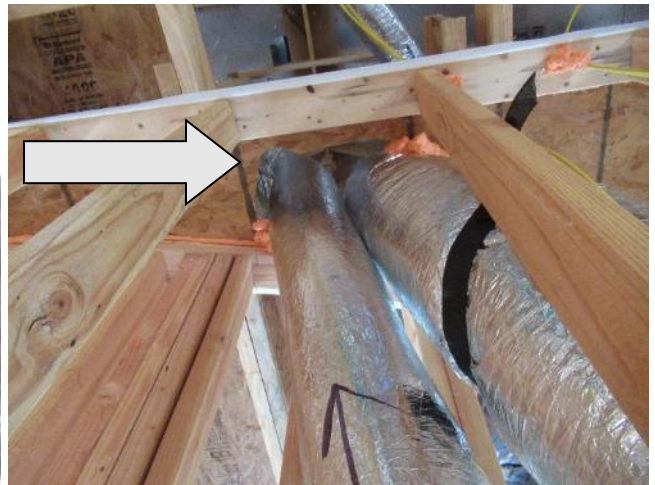
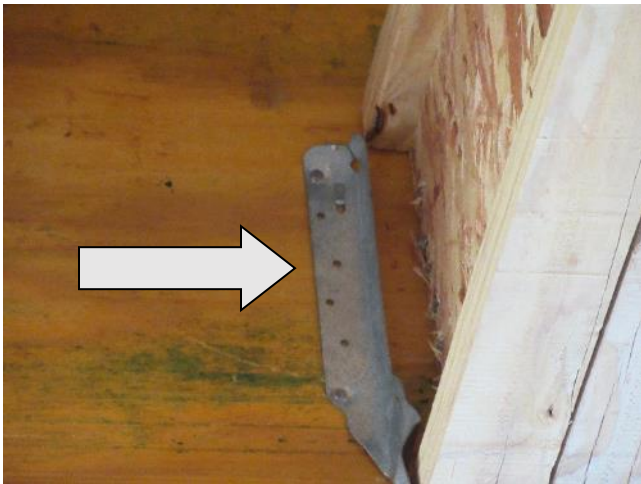
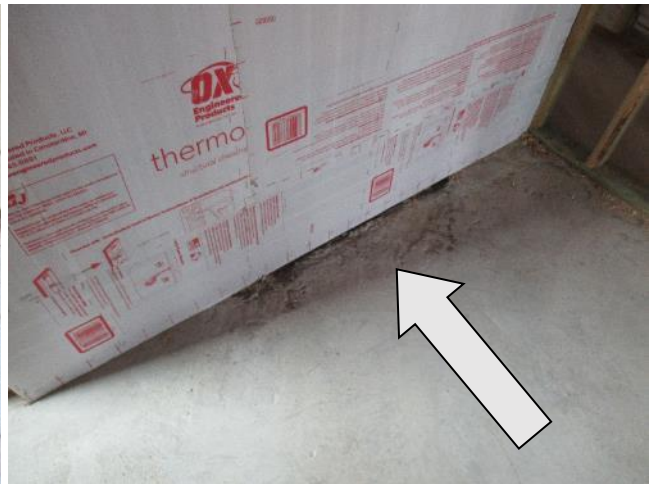
**F. Ceilings & Floors – Comments:** Fireplace flu had a gap at the fire block metal. Front right living room I-beams had holes cut in them for a/c ducts (upper common room floor) holes should not be in the center 1/3<sup>rd</sup> and should be less than 2 inches. Ceiling beam over the stairs not all nail holes were used on the support. Master closet at the bath wall had missing concrete. Small hole in upper closet floor had no fire block. Hole in a/c duct void had no fire block.

Fireplace flu had a gap at the fire block metal.  
Front right living room I-beams had holes cut in them for a/c ducts (upper common room floor) holes should not be in the center 1/3<sup>rd</sup> and should be less than 2 inches.  
Ceiling beam over the stairs not all nail holes were used on the support.  
Master closet at the bath wall had missing concrete.  
Small hole in upper closet floor had no fire block.  
Hole in a/c duct void had no fire block.

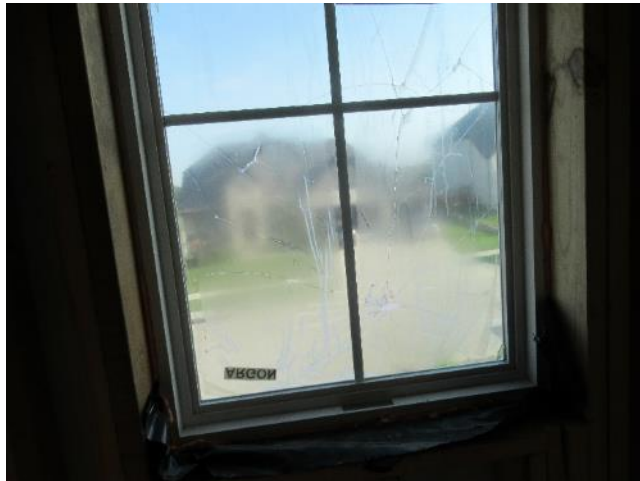
**H. Windows** – **Comments:** 1 media room window was broken.

1 media room window was broken.

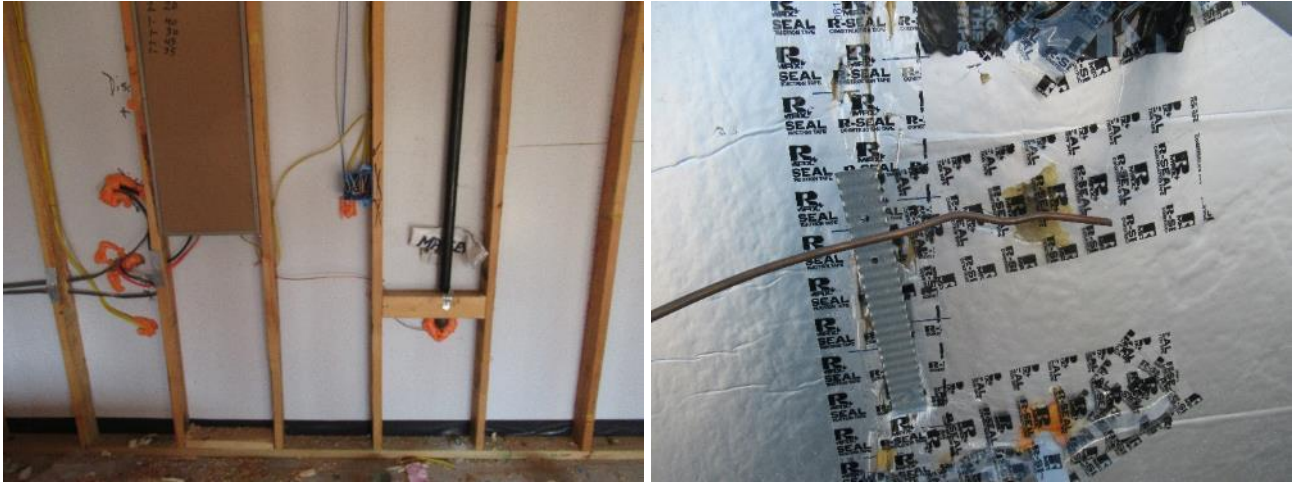
No UFER ground.

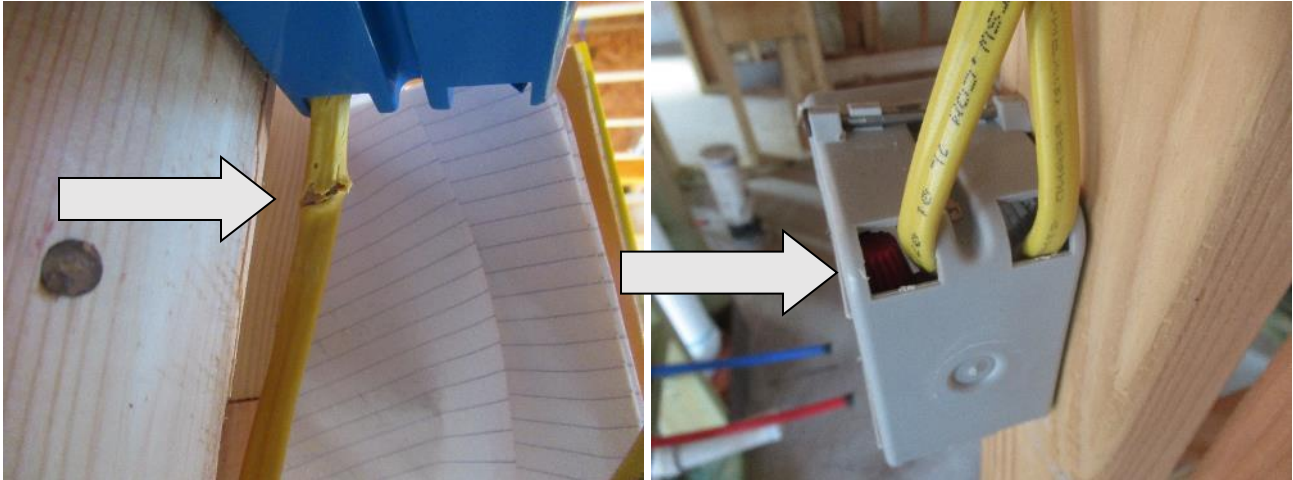
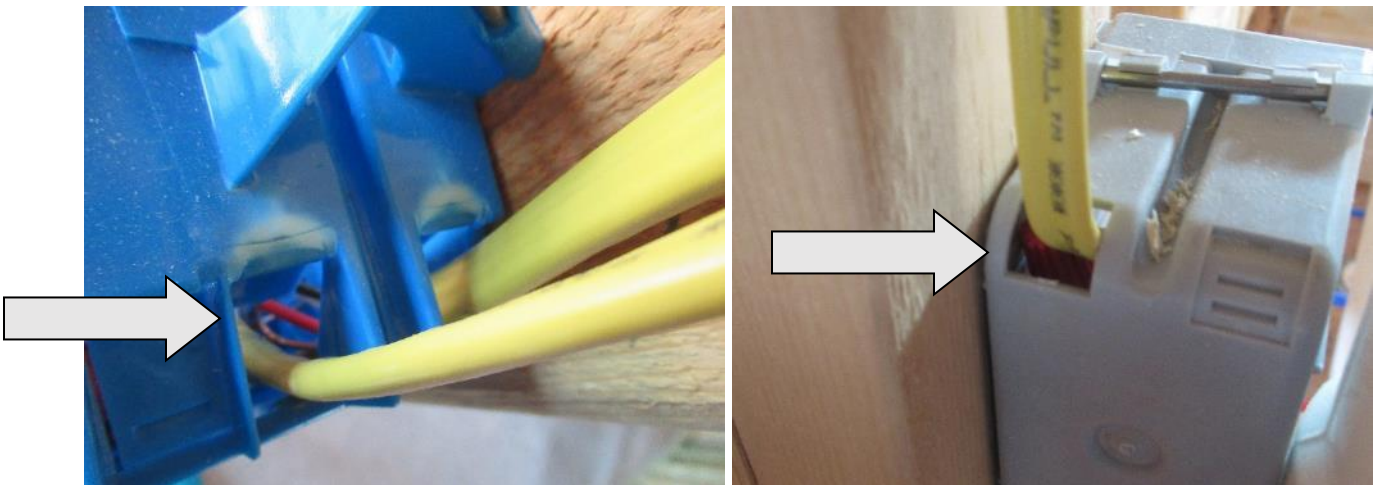
**Comments:** Master bath wire cover was cut. Wire entering each outlet or switch box was not fastened to the box, per standards (some plastic was broken off and others bent). 1 car had no outside light box. A steel plate was not used to protect any hole bored for electric cable that's within 1/4 inches of the edge of a stud or joist, per standards in all areas. Wire is entering each outlet or switch box is fastened to the box, per standards (many were not attached to the box).

Master bath wire cover was cut.

Wire entering each outlet or switch box was not fastened to the box, per standards (some plastic was broken off and others bent).

1 car had no outside light box.

A steel plate was not used to protect any hole bored for electric cable that's within 1 1/4 inches of the edge of a stud or joist, per standards in all areas.

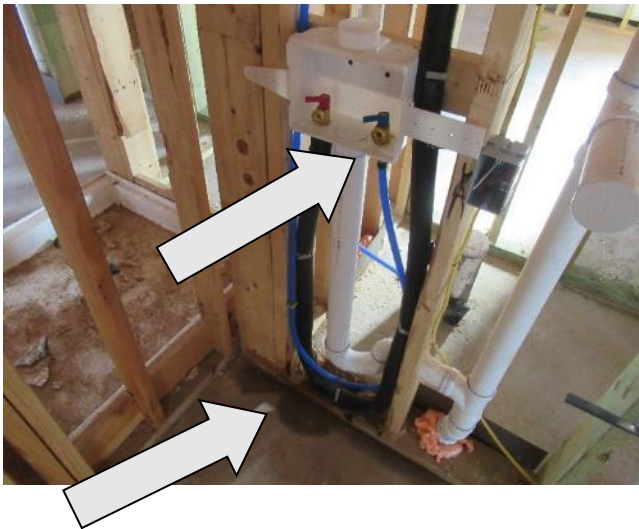
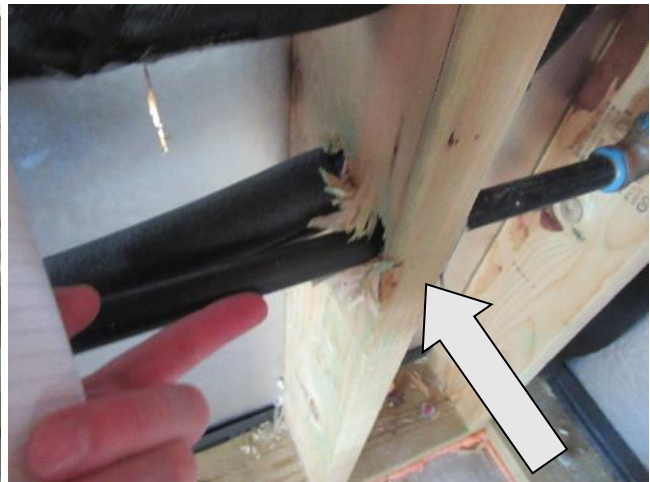
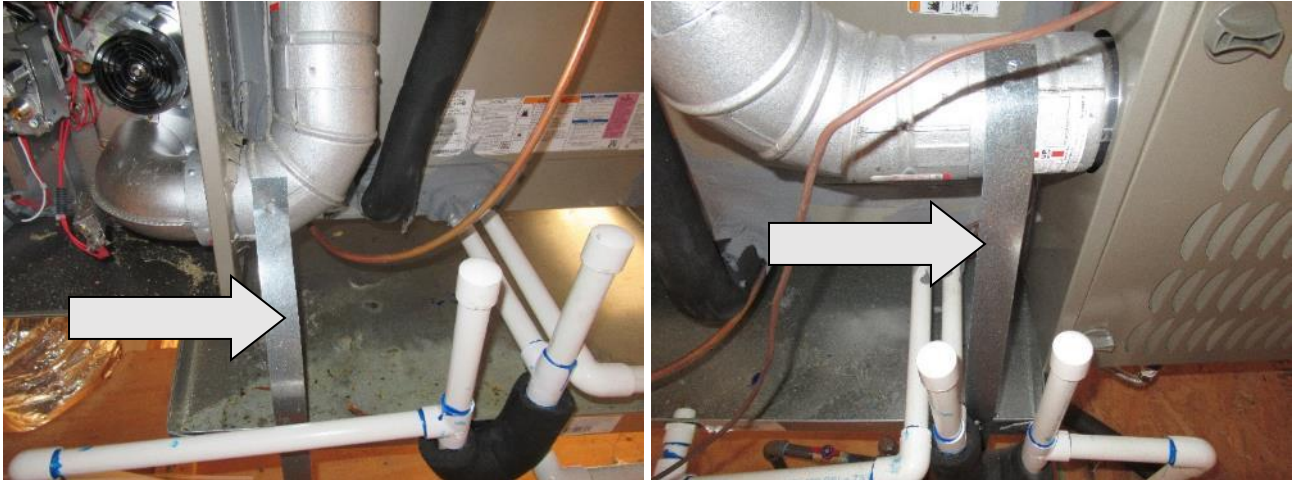
**Comments:** Laundry cold water leaked. Water heater pressure tank was hard to reach. Gas pipe was not protected from physical damage, per standards, and is properly supported, per standards (pantry area had no plates). A/C pans were strapped and screwed to the gas vents for support.

Laundry cold water leaked.

Water heater pressure tank was hard to reach.

Gas pipe was not protected from physical damage, per standards, and is properly supported, per standards (pantry area had no plates).

A/C pans were strapped and screwed to the gas vents for support.
